# **IMPACT TEST REPORT**

## **Bi-Level Motor Vehicle Securement Systems With Bi-Level Products Only**

**TEST REPORT: FI 7- 09**

**June 9, 2009**

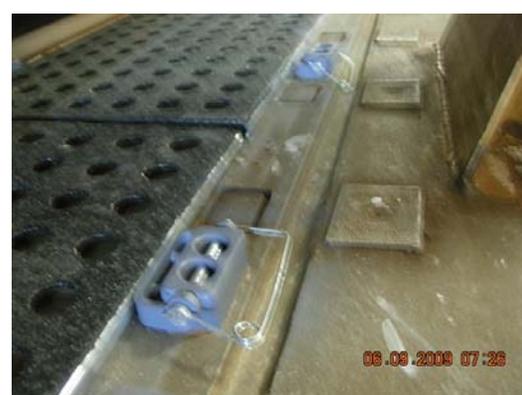
Note Shaft Clips securing decking

debris, snow, ice, etc. from under the track. There is concern with the use of the Shaft Locking pins on the deck that can be lifted to allow cleaning. The locking mechanism of the Shaft Pin is a wire fastener that can potentially be a hazard to snag clothing or footwear or can be easily be disengaged if stepped on. The ability to clean under the decking is desirable but a different locking feature is recommended.

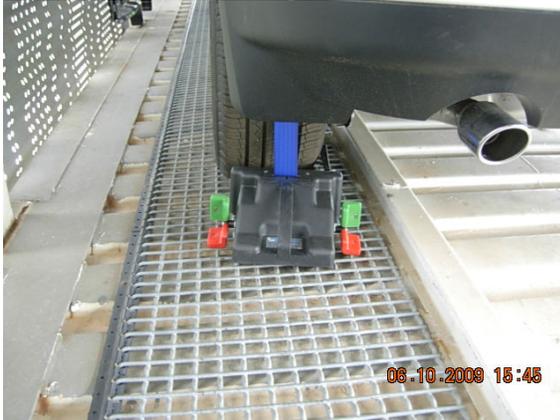
**IMPACT NO. 2 – TARGET SPEED 7.0 MPH FORWARD DIRECTION** – Actual speed was 6.7 MPH; Anvil string wheel slide was 11.5 inches. There was visible movement of all vehicles. The load continued to tighten toward the struck end of the autorack which created slight voids between the tires and face plate of the chock type systems. The left rear chock on the B-2 unit secured with the Holland system became disengaged from the locking track. The locking handle was still in the locked position. There was one very small scratch noted on one cross wire of the floor grating but no other signs to indicate reason for disengagement. There were no broken or otherwise defect components of any kind visible. All locking teeth, levers and all components appeared to be intact and undamaged in any manner. There was no visible damage to the railcar or to the vehicle. It appeared likely that the chock may not have been full and correctly applied to the grating but an exact cause for the release is unknown.

View of disengage Holland chock.

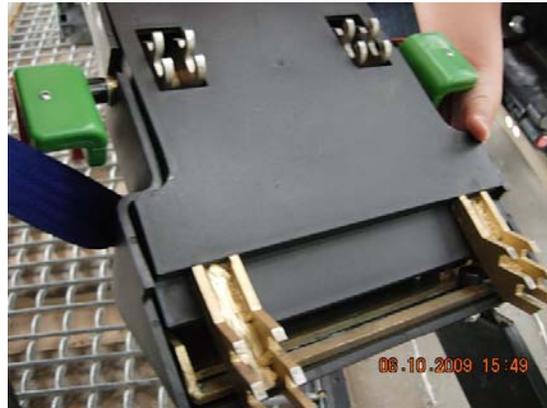
Underside of chock with no witness marks.

**HOLLAND CO.** - The reason for the Holland chock disengagement remains unknown but was likely due to incorrect installation. Users of this system must be aware of the retracting feature of the strap and be aware that it retracts quite quickly and may potentially contact a vehicle causing damage or cause personnel injury. Care must be exerted to control the hook end during this procedure. The strap also has moveable rubber cleats that are to be positioned in the tread area of the tire when installing the system. These cleats must also fully retract, or be moved by hand, to be against the chock to allow proper chock storage. Both the positioning of the cleats during application and ensuring the strap is fully retracted and the cleats are in proper position when storing will likely be an issue that will require considerable training with loading and unloading crews. The Holland system did not experience the problem of hook removal as the other systems that used a hook. The system is relatively easy and fast to apply and remove. The chock is relatively heavy and feels out of balance when handled by the handle which is at the end of the chock. Most of the weight is forward of the handle making the chock very “nose” heavy and difficult to hold in a level position.

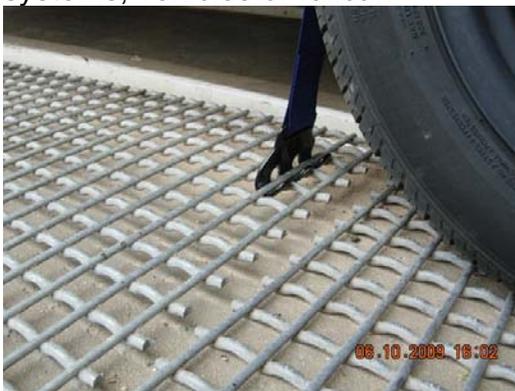
**IMPACT NO. 3 – TARGET SPEED 8.0 MPH FORWARD DIRECTION** – Actual speed was 8.0 MPH; Anvil string wheel slide was 23 inches. There was visible movement of all vehicles but all were contained by the securement systems. The grating at the B-2 unit secured by the Holland system was pulled upward approximately 1 inch but did not appear to be bent. The grating appeared to only be under tension and not permanently deformed. (Note – This was observed later during the test after the tension was released and the panel returned to its original shape with no visible permanent deformation). There were no other exceptions of any kind noted with any of the other systems, vehicles or railcar.

View of lifted grating.

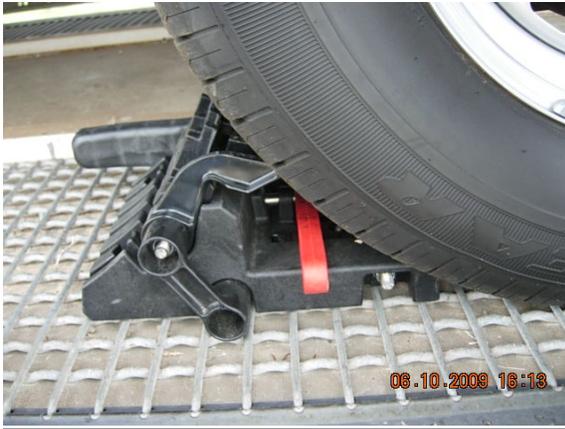
**IMPACT NO. 4 – TARGET SPEED 9.0 MPH FORWARD DIRECTION** – Actual speed was 8.9 MPH; Anvil string wheel slide was 25 inches. There was considerable visible movement of the vehicles and the A-3 (Dodge Ram 4x4 secured by the ZefTek system) vehicle moved over the front chocks. The upper face plate of both front ZefTek chocks was severely permanently deformed. There was no visible damage to the vehicle or railcar nor to any other chock system, vehicles or railcar.

View of vehicle tire out-of-chocks.

**ZEFTEK** - At 8.9 MPH the Dodge Ram vehicle in the A-3 position secured by the ZefTek product without a strap, moved over the chocks. This is a large vehicle and both front chocks were severely distorted (permanently) but not fractured during this incident which was far above normal coupling speeds. The chock is relatively heavy and feels out of balance with much of the weight forward of the normal handling position. This makes it difficult to handle. The system performed well in all other impacts. There is concern with the strap application as it pulls directly vertically on the chock body which is a different force than in the original design. There were no problems with this during the test but should continue to be monitored.

**Note:** The front chocks on the A-3 unit were replaced prior to the reverse impact.

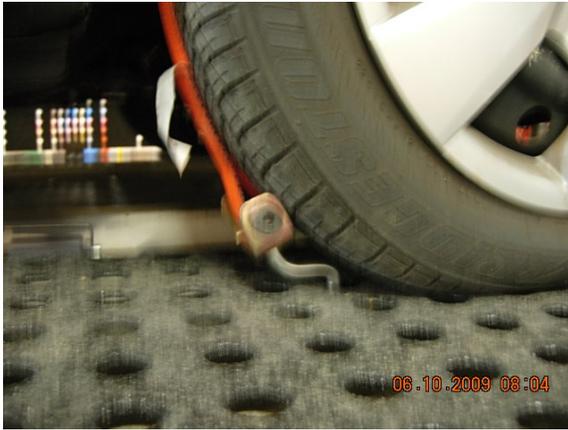
Upon completion of the test, the securement system could not be removed until the vehicle was moved due to the curvature of the tire being over the securement hook which prevented the hook from being released from the track. There was only slight movement of the vehicle during the test but it was sufficient to prevent hook release. This is a major concern that would affect unloading personnel. The strap system is somewhat difficult to handle because of the winch at the end of the strap and the various hooks used to secured the strap to the deck. Application is more time consuming the other systems.

View showing hook blocked by tire.

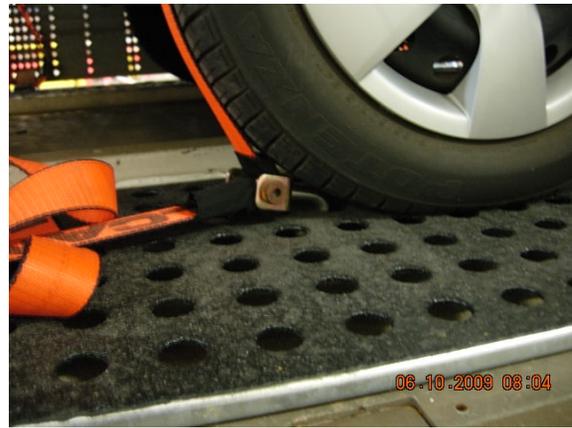
Example the idler hook blocked.
