ASSOCIATION
OF AMERICAN
RAILROADS

Universal Securement Chock Loading Study April 2010 Update

VEQ Universal Securement Test Loading Summary 4/2010

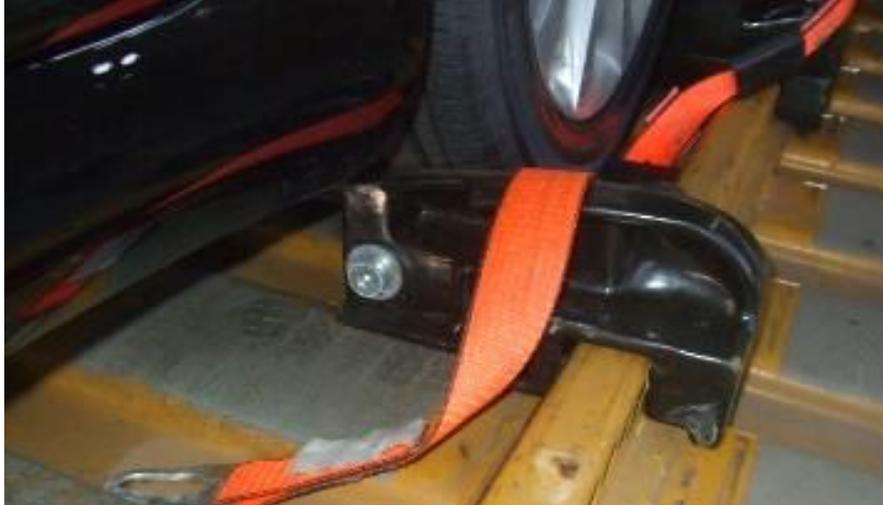
Trinity Tri-Level Chocks

The photos above and below show vehicles arriving at Destination with the front tires turned.

Chocks held no vehicle damage reported

The photo above, shows a “C1” positioned vehicle arriving at Destination with the LR strap key lock disengaged and strap off the tire.

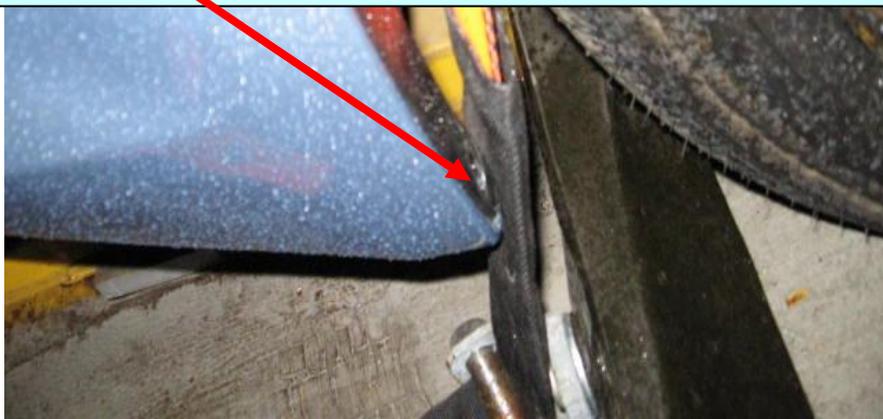
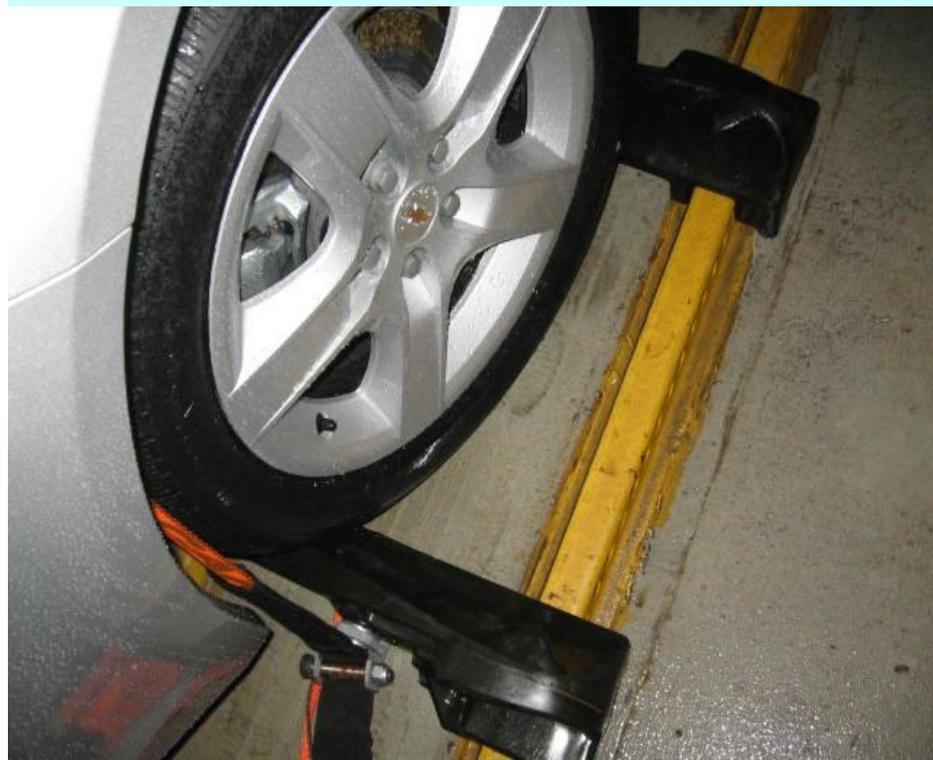
The photo below, shows a vehicle that shifted rearward slightly in the chocks causing a gap between the tire and the chock. Please note the strap contact.

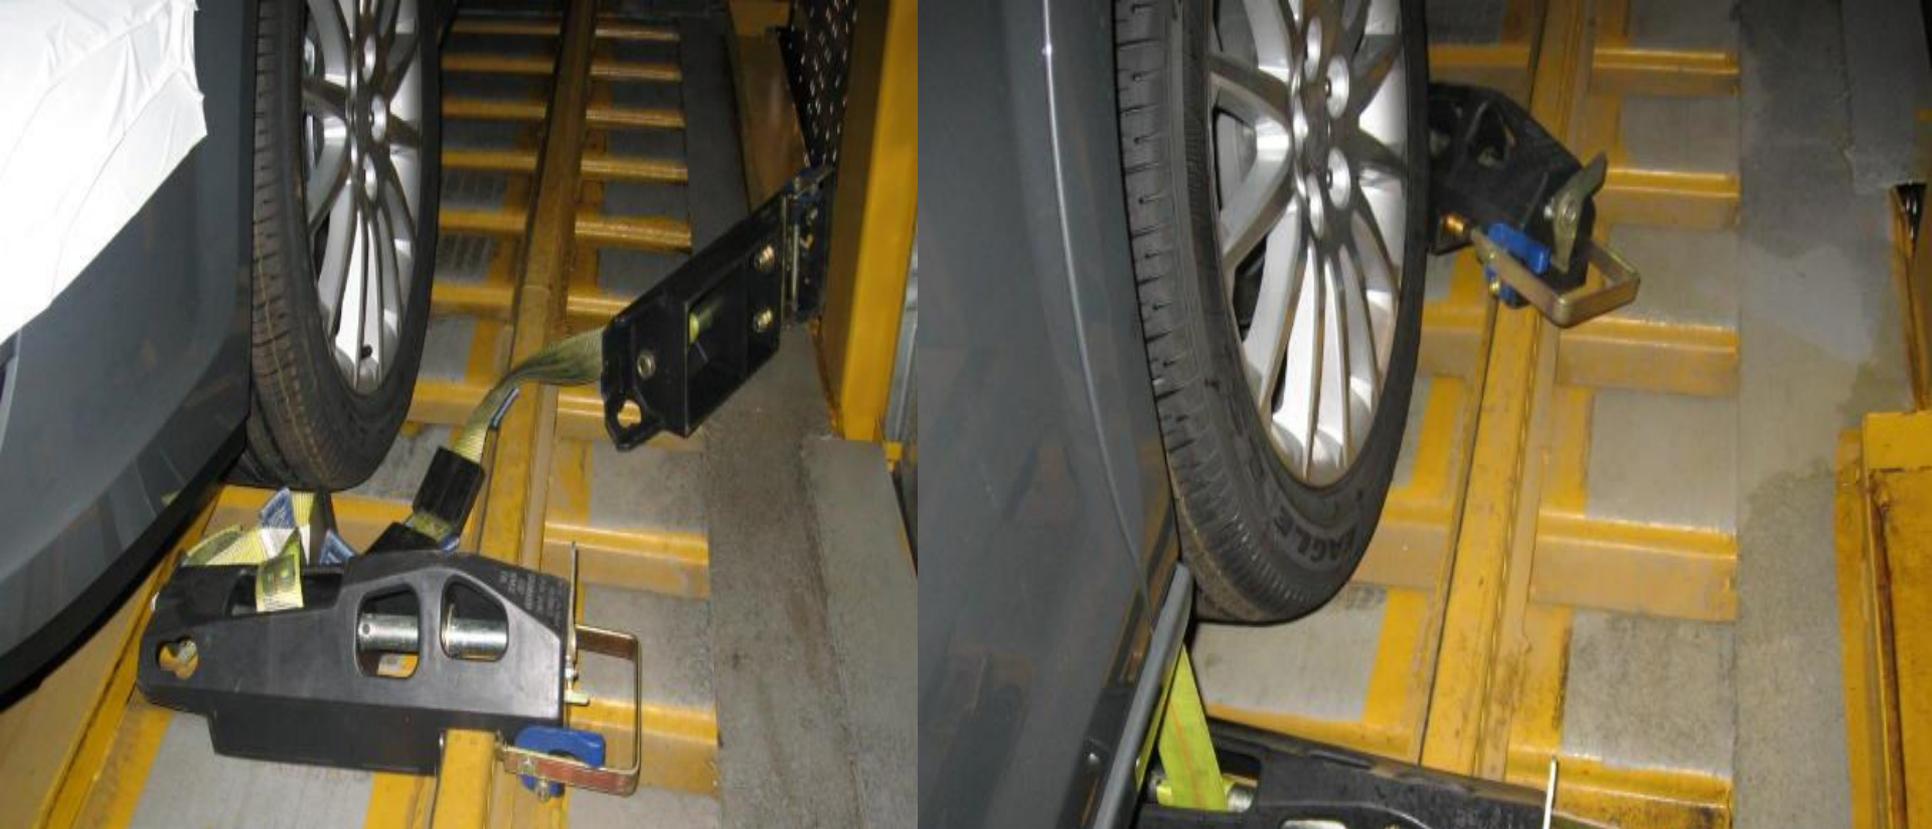
Zeftec/SCT (Low Pro) Tri-Level Chocks

The photos above and below shows the “C3” positioned vehicle on ETTX 853880 Waybill date 3 21 09. The Left front/rear chocks were disengaged.

Although several vehicles were involved in the load shift reported at destination, no vehicle damage was reported. Since January 2010 no chock or strap disengagements have been reported on chocks reports received.

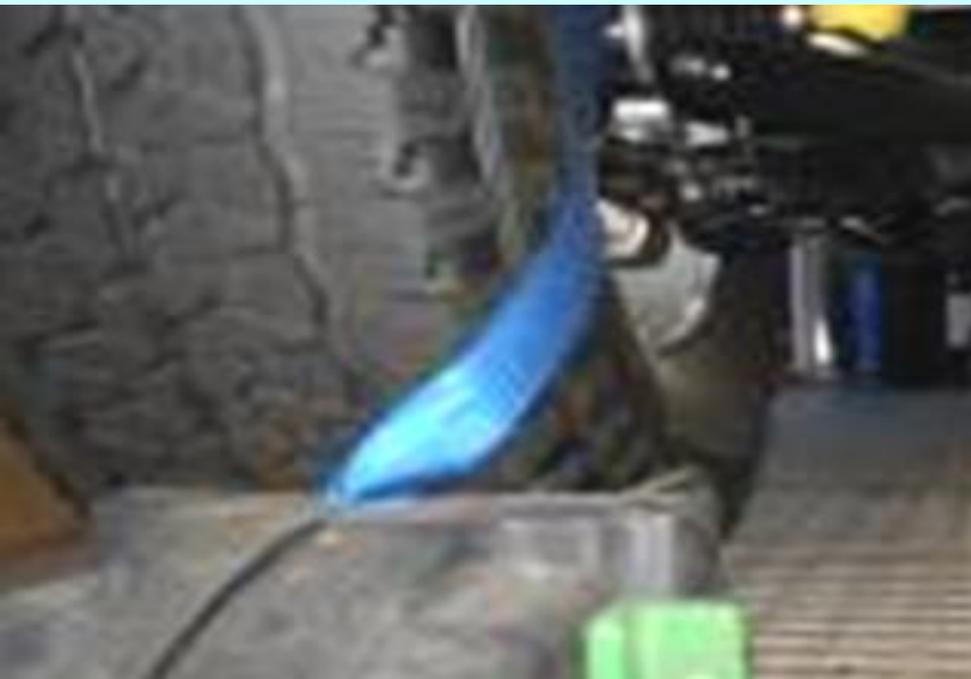
The photos above and below show vehicles at destination on TTGX 254046 Waybill date 3 3 2010.

No vehicle damage was reported.

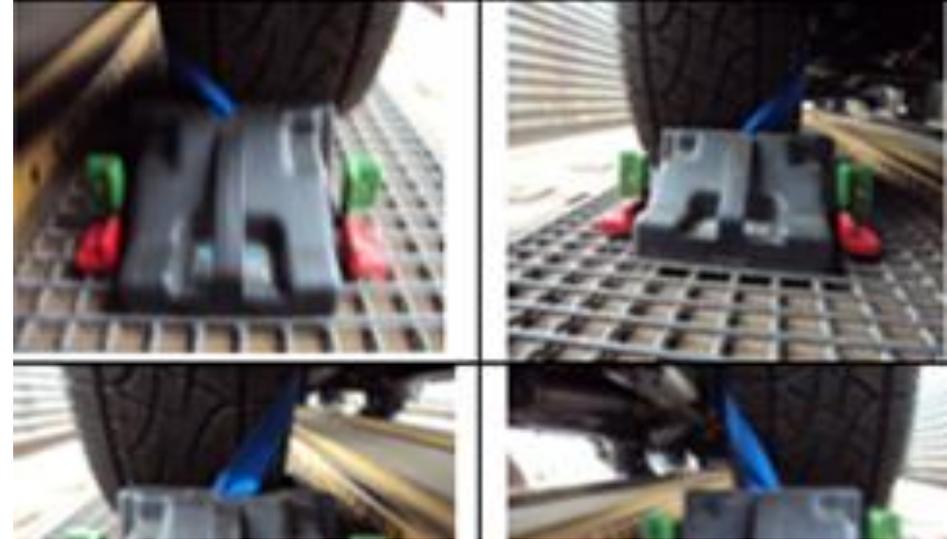
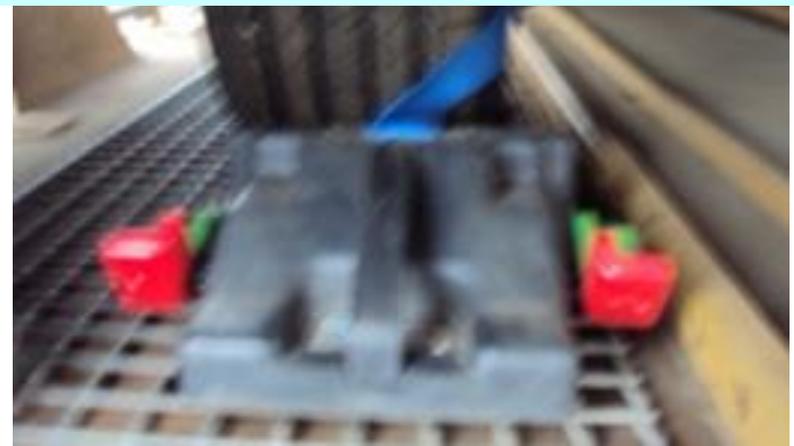
The photos above and below show the "A-3" and "A-5" positioned vehicles at destination on TTGX 254046 Waybill date 4 16 2010. Although several chock defects on this load were observed.

No vehicle damage was reported.

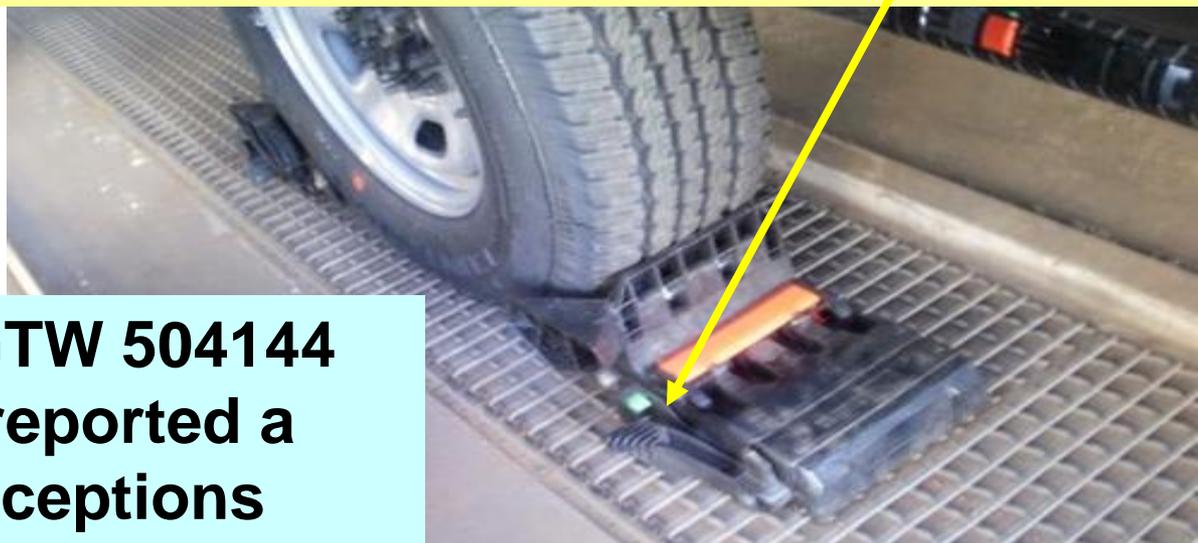
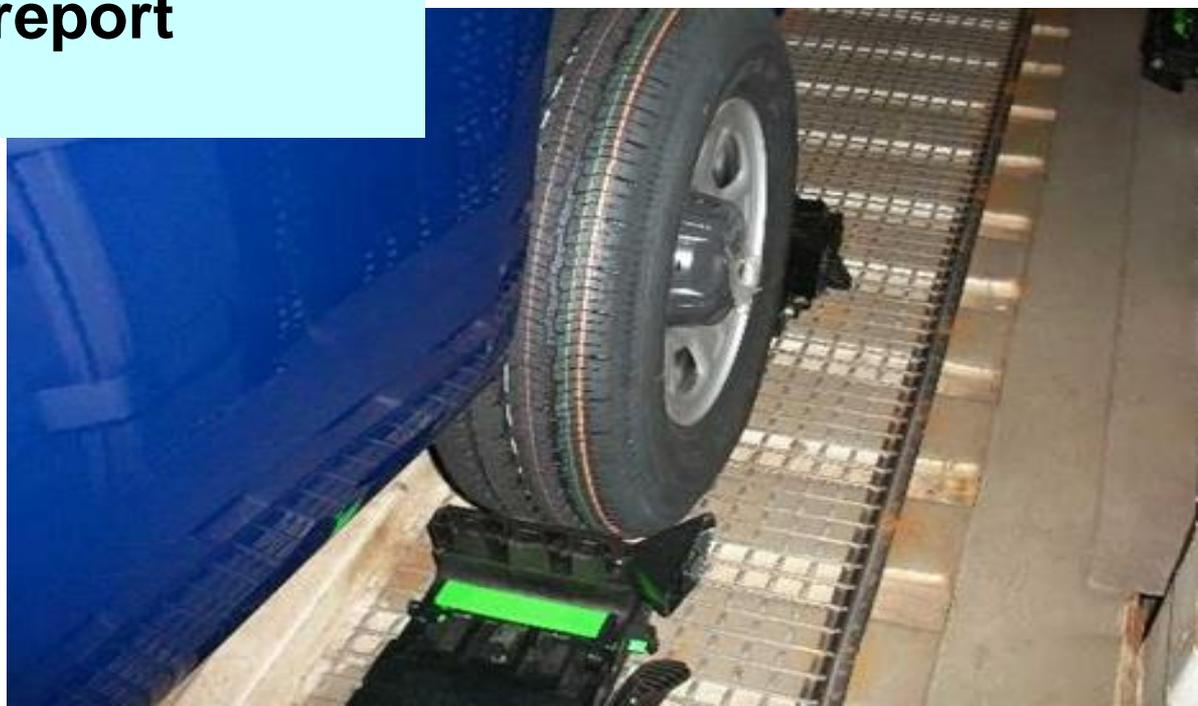
**Destination report on GTW 504144
Waybill date 1 20 2010 reported a
chock exception. No exceptions
could be found on any report
received thus far.**

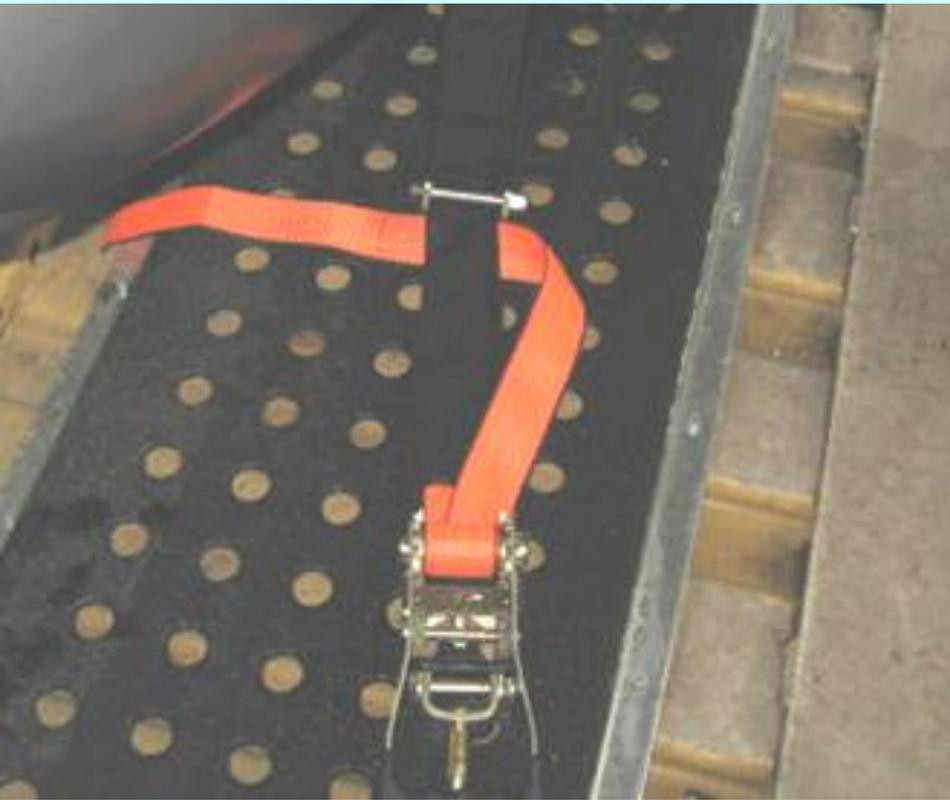
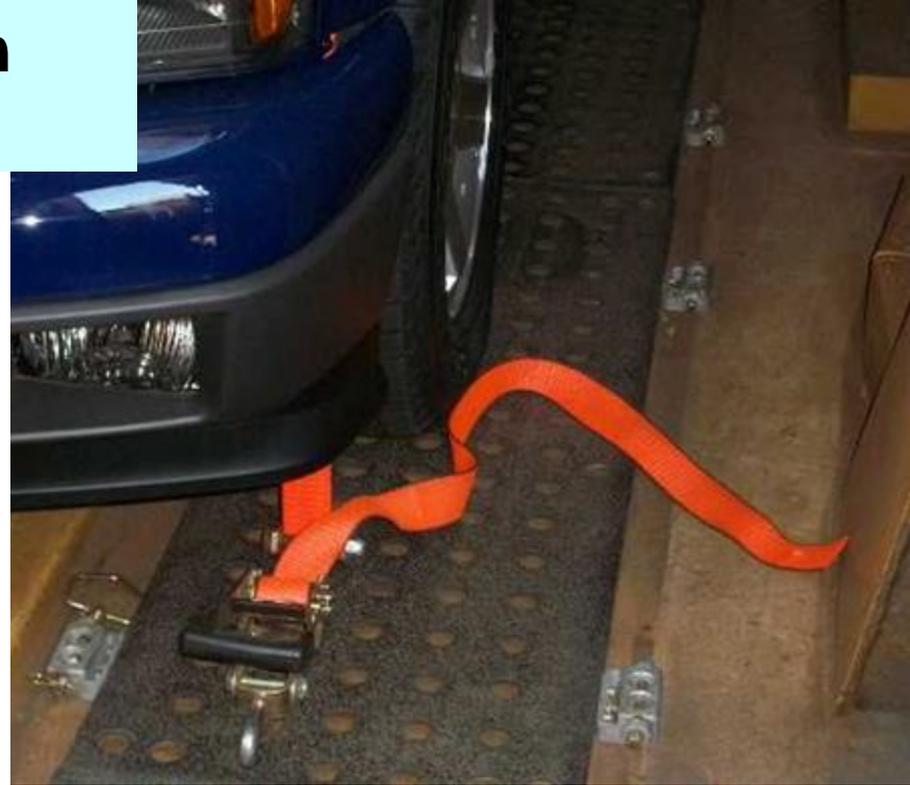
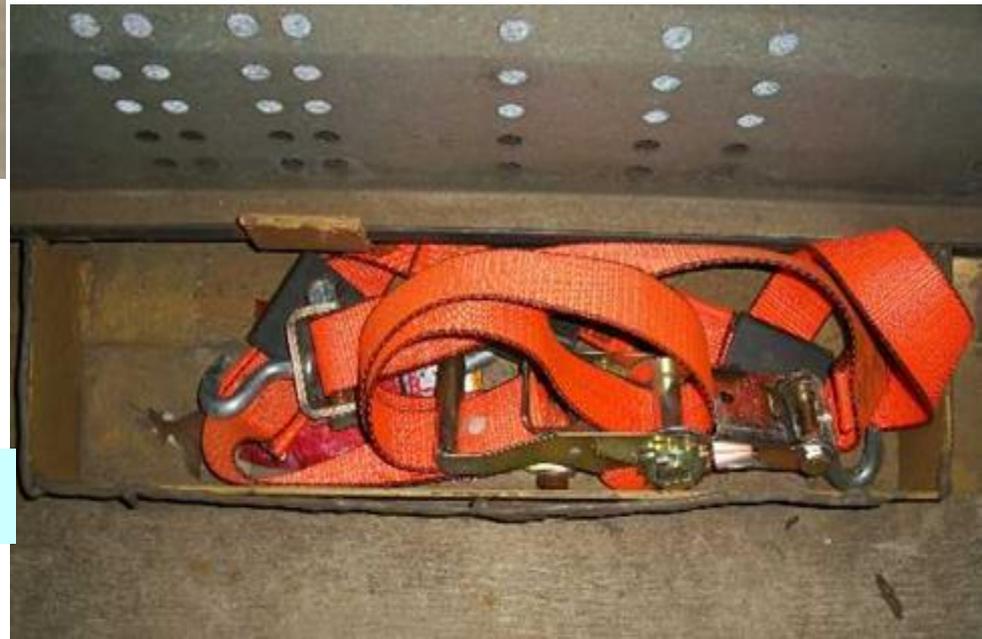
- Anti-abrasion sleeve becomes torn and/or missing easily.
- Tripping hazard when fastened to grate.
- Can cause damage to bumpers when pumping handle to loosen strap.
- Can potentially snag fingers.
- Exposed metal from handle and hooks can damage vehicle if it makes contact.
- Loosening strap time-consuming and clumsy compared to chock.
- All ratchet handles are out board.
- All straps require hand and knee installation.

No exceptions could be found on any report received thus far.

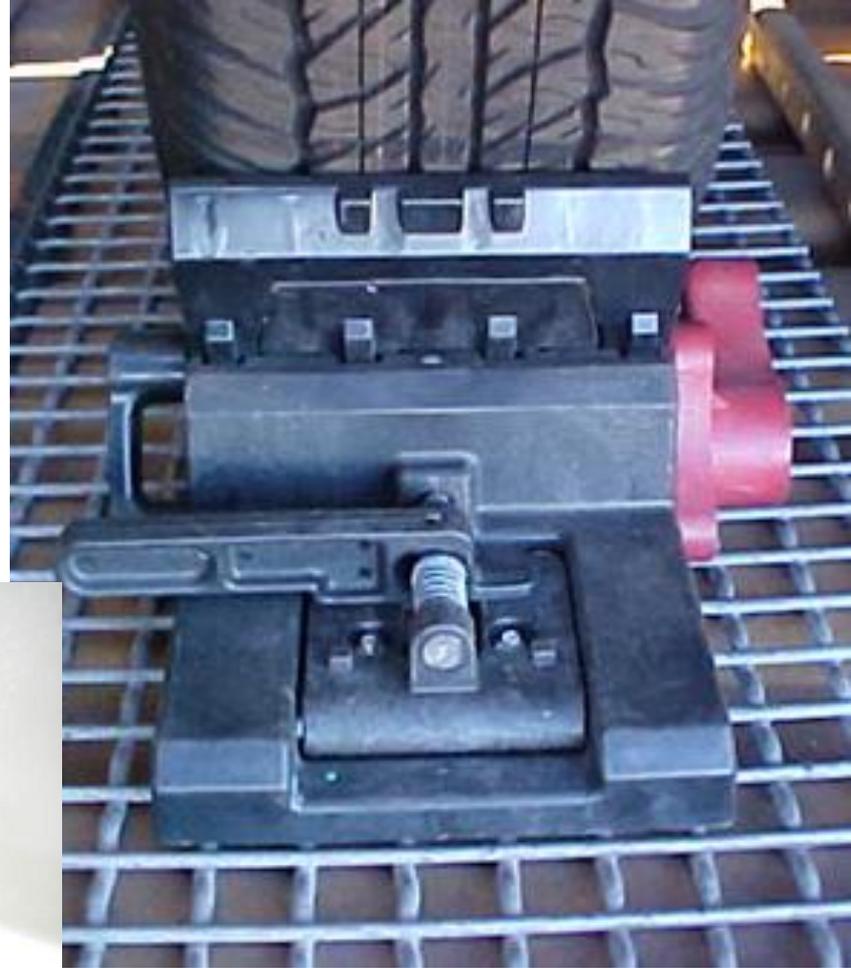
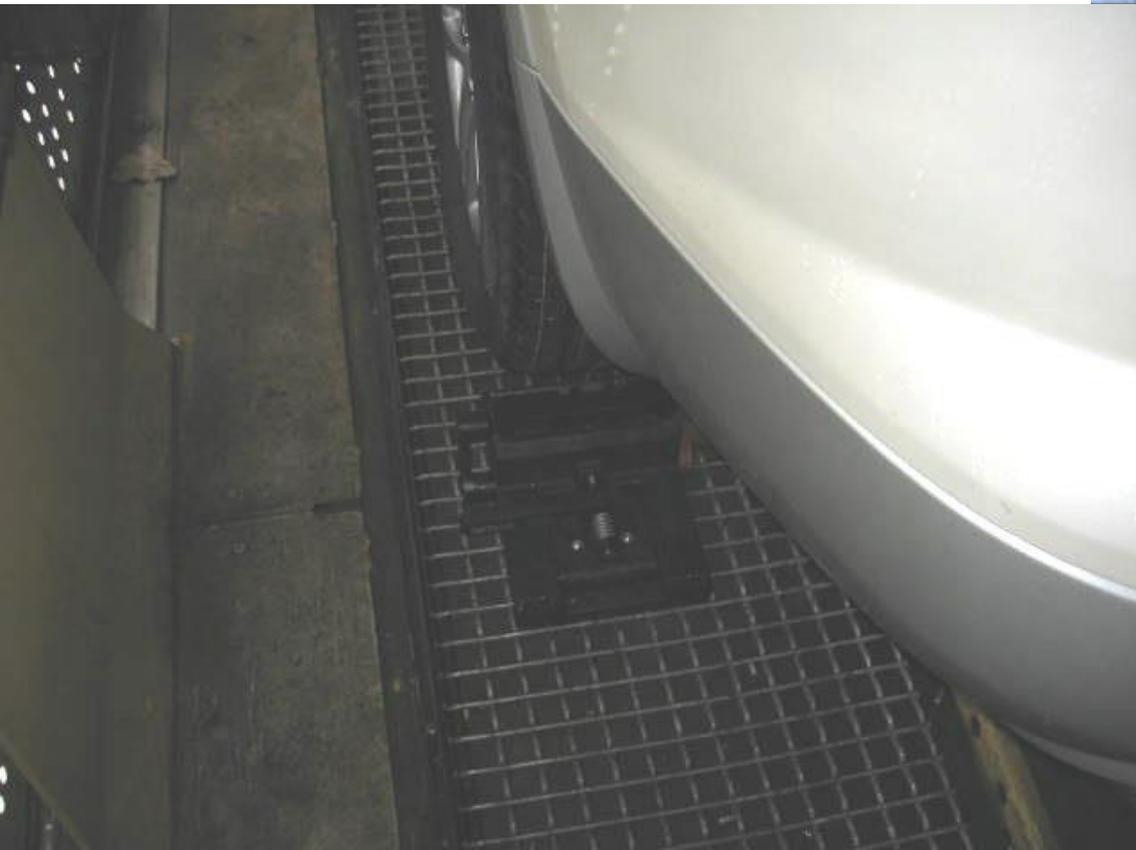
- Unloaders stated that it took a lot of force to disengage the release pin when a tire was in hard contact with the chock.
- Installers feel that chock is too heavy and needs a centralized handle to hold the chock
- Unloading CO. states, flimsy release handle will break.
- When on a split grate unit has to be moved to secure chock.
- Potential long term back issues due to weight and two handed installation.
- Locking lever, in locked position comes out past tire, possible foot contact may unlock chock.
- Repetitive installation may cause wrist fatigue.
- Loaders disliked the strap configuration with this chock. They found it difficult to attach the hooks to the chock body. Concern was also raised about the lack of a rubberized coating on the strap hardware and the resulting exposed metal. .
