ASSOCIATION
OF AMERICAN
RAILROADS

Universal Securement Chock Loading Study March 2011 Update

VEQ Universal Securement Test Loading Summary 3/2011

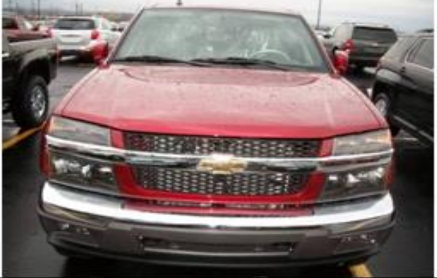
| Pos | Photo info | Insert Photos | |
|---|---|---|---|
| | Comments: Straps slipped off of 3 of the 4 tires. | Insert Photo | Insert Photo |

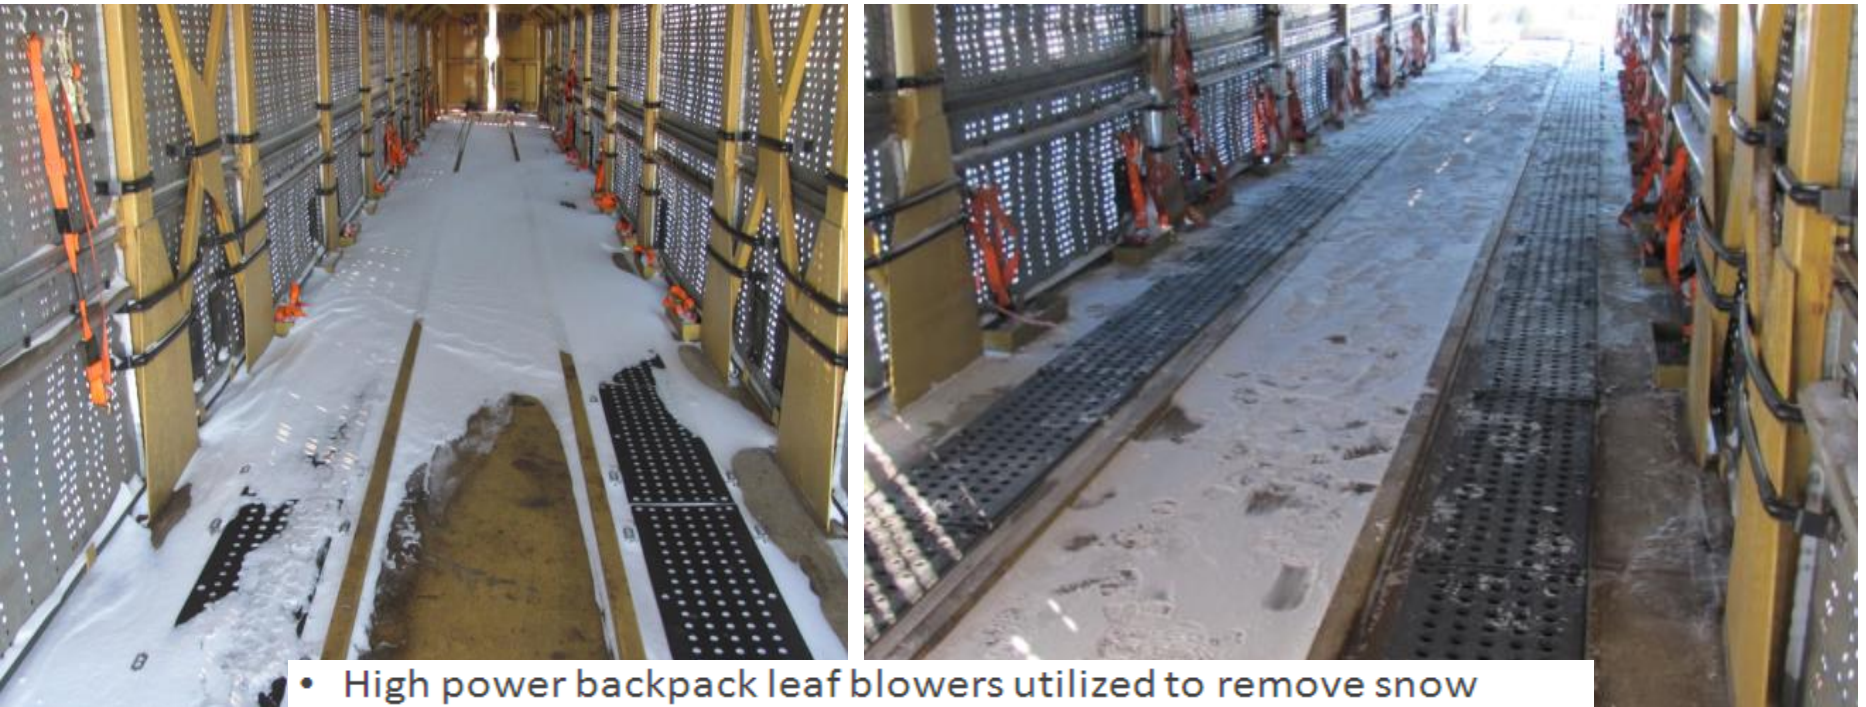
Trinity Bi-Level Chocks Snow and Ice Test

- High power backpack leaf blowers utilized to remove snow
- All securement holes in the decking were free of ice and snow
- Areas where decking was hinged were not lifted
- All ratchets and straps in proper working order
- Total time in pre-trip process was 16 minutes

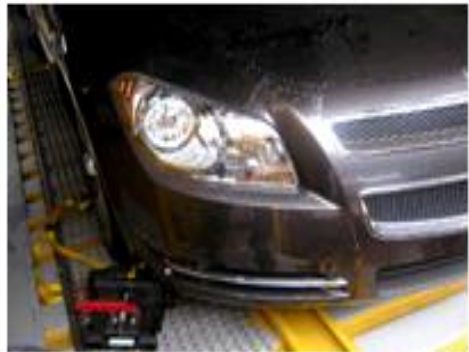
| Photo info | | Insert Photos | |
|---|---|---|---|
| Comments: | Right Front Chock release | | |
