Holden Grate-Lock® Chock Inspection and Repair Standards: Procedure and Examples (April 2016)

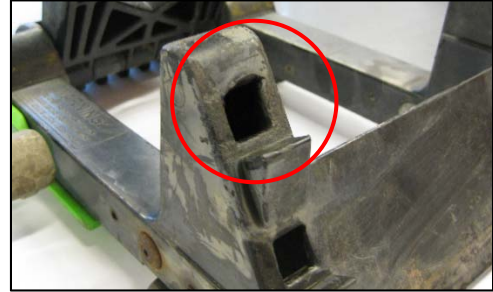
- a) The tab engagement holes, found on the Base tower front faces, should be checked for elongation. If the holes are elongated (see Figure 2), the chock is considered to be non-functional and must be replaced.

Figure 2: Elongated Tab Engagement Holes

a)	Base Tower Tab Engagement Holes	Elongated	No	Send for Reconditioning	
	b)	Base Tower	Face Plate does not sit properly	No	Send for Reconditioning	
	c)	Base Cross Web	Strain whitening marks in corners or visible deformation	No	Send for Reconditioning

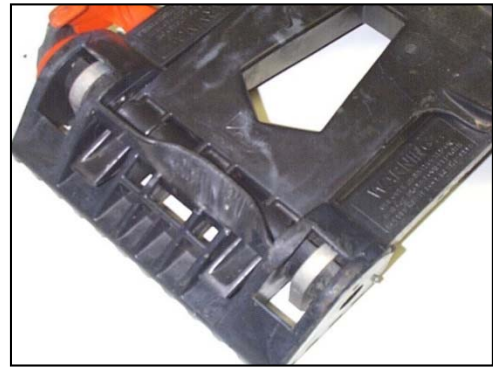
- c) Deformation of the cross web on the top side of the chock Base or strain whitening marks found in the corners of the cross web indicate a weakened structural component. (See Figure 3). In both cases, the chock is considered to be non-functional and must be replaced.

Figure 3: Deformed Cross Web on Base

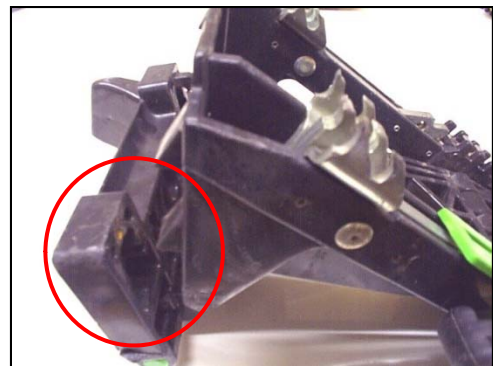
- e) The Face Plate tabs should be checked to ensure that they are neither missing (see Figure 4), nor bent, nor have a hairline crack where they meet the Face Plate. In the latter case, the chock may still appear to be fully functional. However, in all cases the chock is considered to be non-functional and must be replaced.

Figure 4: Missing Face Plate Tabs

d)	Strut Side Restraint Paddle	Deformed, bent or cracked near main body	No	Send for Reconditioning	
			Hairline cracks in webbing			
	e)	Face Plate Tabs	Missing, deformed or hairline crack	No	Send for Reconditioning

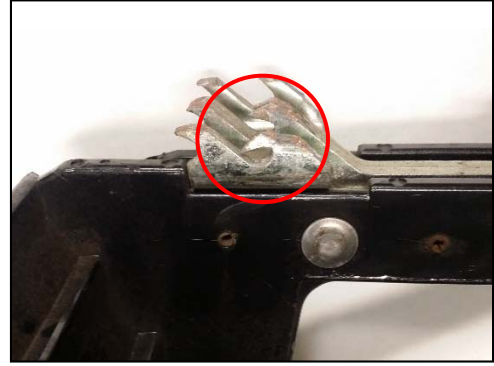
- a) Verify that the left, the right, and the center Steel Teeth Plates are all present and not damaged. If any Steel Teeth Plate is missing or adjacent Tooth tips are bent (see Figure 7), the chock is considered to be non-functional and must be replaced.

Figure 7: Bent Adjacent Tooth Tips

C. Underside Components	a)	Steel Teeth Plates	Missing Plates or Adjacent Tooth tips bent	No	Send for Reconditioning	
	b)	Grating Latch Teeth	Deformed or broken	No	Send for Reconditioning	
	c)	Base Cleats	Two adjacent or three cleats over entire waffle area broken or missing	No	Send for Reconditioning	
			Any two non-adjacent cleats over entire waffle area broken	Yes	Repair in the Field	Grip the cleat firmly with pliers and bend away from the Base until it breaks off. Use a file to remove any residual shards.

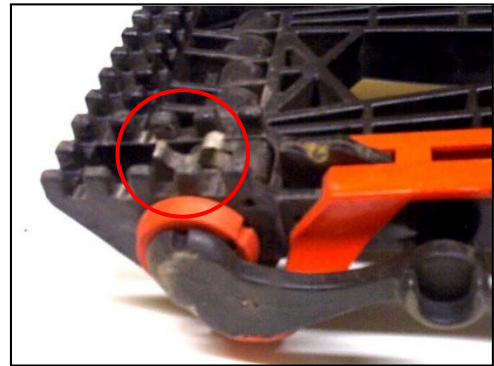
- b) The Aluminum Cam Latches must be checked for distortion or elongation. If any latch tooth is deformed or broken off (see Figure 8), the chock is considered to be non-functional and must be replaced.

Figure 8: Broken Cam Latch

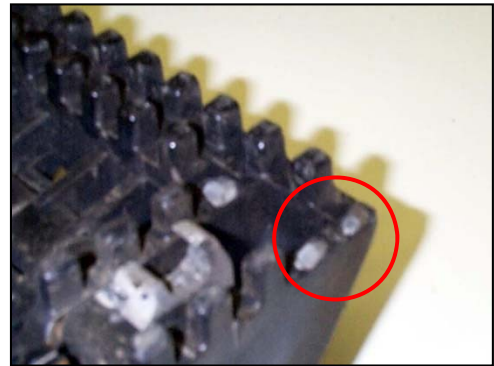
- c) All the cleats in the “waffle area” found on the chock underside should be straight. If two adjacent cleats or more than three cleats over the entire waffle area are missing (see Figure 9), the chock is considered to be non-functional and must be replaced.

Figure 9: Missing Cleats on Waffle Area
