IMPACT TEST REPORT

Bi-Level Motor Vehicle Securement Systems With Bi-Level and Tri-Level Products

TEST REPORT: FI 8-09

SUBJECT: Test of Motor Vehicle Bi-Level Securement Systems With Bi-Level and Tri-Level Products

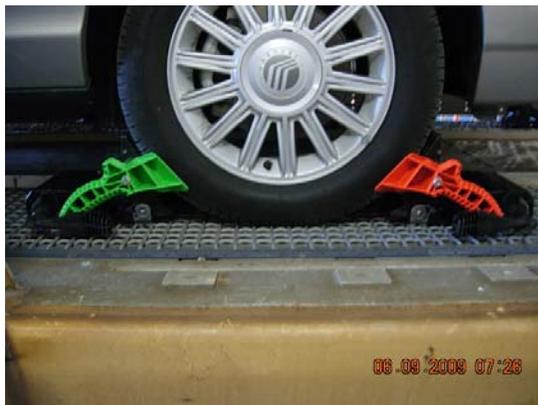
View of Holden America's system.

The **Holden America** system is an eight chock per vehicle system (2 chocks per wheel) that attaches to the chock grating currently equipped on most of the bi-level fleet. Vehicles are secured by a colored coded chock applied inboard and outboard of each tire. A Lime green colored chock is applied to the **Left** side of the tire as a loader faces the tire, and a **Red** colored chock is applied to the **Right** side. The chock is constructed with a platform that attaches to the grating and when the locking handle is engaged the faceplate and upper portion of the chock moves forward to fill any void space between the tire and faceplate. The lateral restraint provision is applied to the outside of the tire. This lateral restraint is angled so that it contacts the outer tread area of the tire and not the sidewall. The chock is adjustable in height.

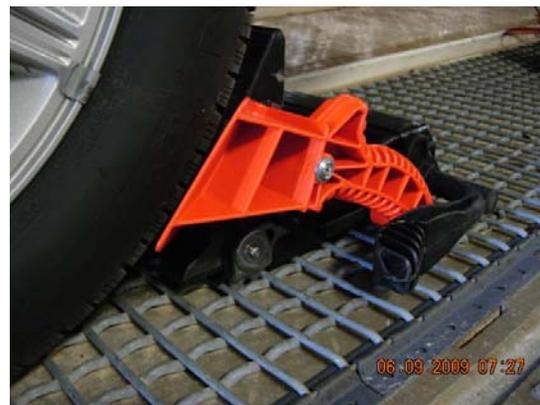
View showing lateral restraint paddle.

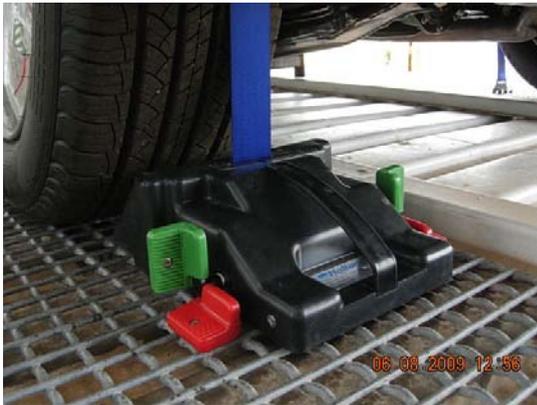
View of the Holland chock system.

The **Holland Company's** system is a four chock system (one outboard of each tire) with each chock equipped with a strap that is to be placed over the vehicle tire and secured to the grating with curved locking fingers. The strap operates similar to a shoulder/seat belt in a vehicle as any slack that is created is automatically retracted. The chock has a lateral restraint paddle that is adjustable to either side. The chocks attach to the grating currently equipped on most of the bi-level fleet. The system locking handle is color coded **Red** and **Green** to indicate if the chock is locked in position. The strap has moveable rubber cleats that are to be positioned in the tread area of the tire when installing the system. These cleats also must fully retract to allow proper chock storage.

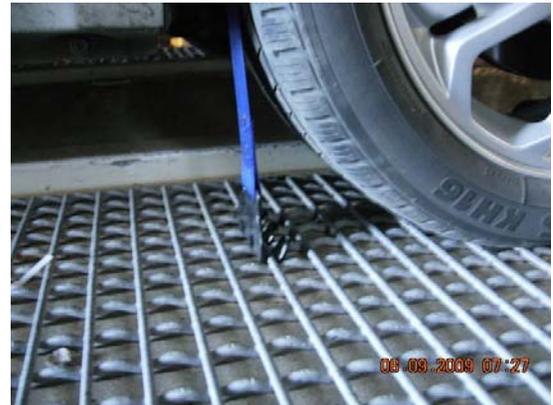
View showing the attachment to grating.

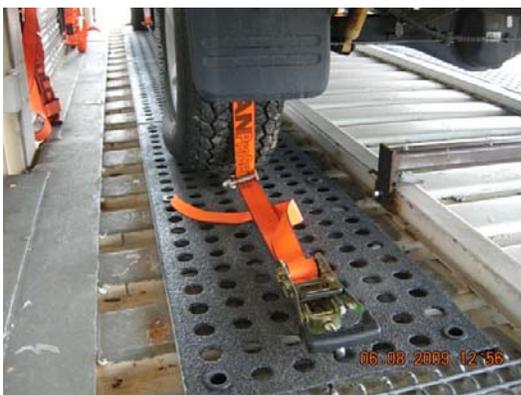
Strap system and huck bolted decking.

The **TrinityRail** system was a strap only system that required a special track to be installed on the deck of the autorack to provide attachment points. The system included a strap, idler, hooks and a remotely placed and operated ratchet winch. The decking is $\frac{3}{4}$ inch in height with punched holes to accept securement hooks and is coated with an anti-skid material. Two systems were used to secure the decking to the car body. One system was huck bolted to the deck so it cannot be moved. The second system was attached with removable Shaft Locking pins which can be removed on one side of the deck so it can be raised for access under the deck for cleaning purposes.

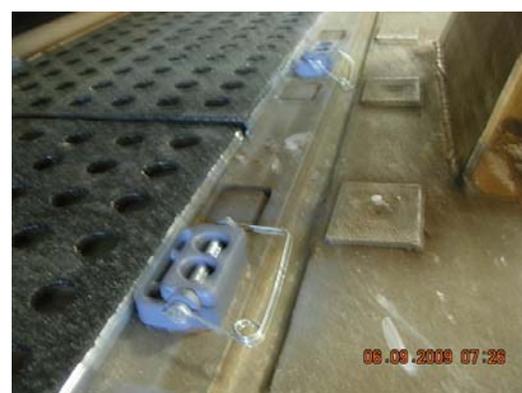
Note Shaft Clips securing decking.

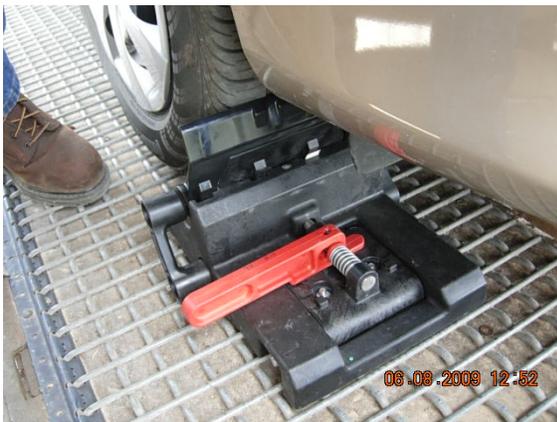
View of ZefTek chock system w/o strap.

ZefTek had two versions of their system, one with a strap for added vertical securement and one system without a strap. Both versions were a four chock system (one chock outboard of each tire) that will attach to the grating currently equipped on most bi-levels. The strap, on the system with a strap, attached to the chock with a hook and the other end attached to the track with curve “fingers” designed to engage the grating. The strap has a buckle to allow tensioning . The chock faceplate is adjustable in height.

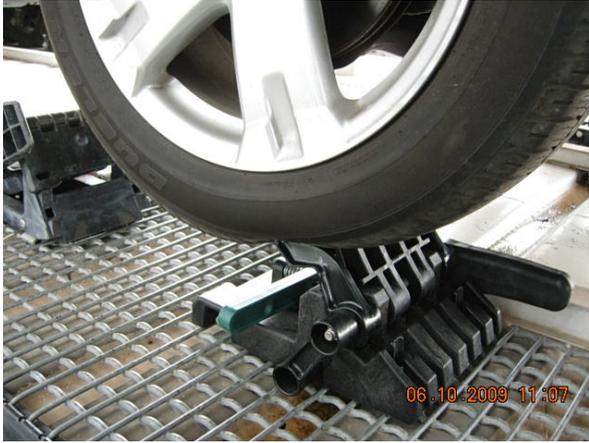
“Perched vehicle” on ZefTek device.

IMPACT NO. 4 – TARGET SPEED 9.0 MPH FORWARD DIRECTION – Actual speed was 8.8 MPH; Anvil string wheel slide was 22.5 inches. There was considerable visible movement of the vehicles and the B-4 (Toyota RAV) vehicle moved out of the chocks and perched on top of the front chocks. The upper face plate of both front ZefTek chocks was severely deformed but did not fracture. The securement hook at the left rear tire of the A-1 unit secured with the ZefTek system equipped with a strap was severely blocked by the tire making it impossible to remove without moving the vehicle. The decking of the B-1 unit with the TrinityRail system remained under tension and raised ½ inch. There was no visible damage to any vehicles or railcar, the only noted damage was to the front chocks of the B-4 unit. The TrinityRail storage system with the hook placed through a hole in the side screen remained intact.

At 8.8 MPH (well above normal acceptable handling practices) the Toyota RAV in the B-4 position secured with the ZefTek system without straps perched on the front chocks. The front chocks were severely deformed but there was no fracture. There was no visible damage to the vehicle or railcar. Due to the extreme movement of the B-4 vehicle, straps were added to the ZefTek chocks for subsequent impacts as an added measure of safety. The system contained the vehicle throughout the remainder of the test without exception.

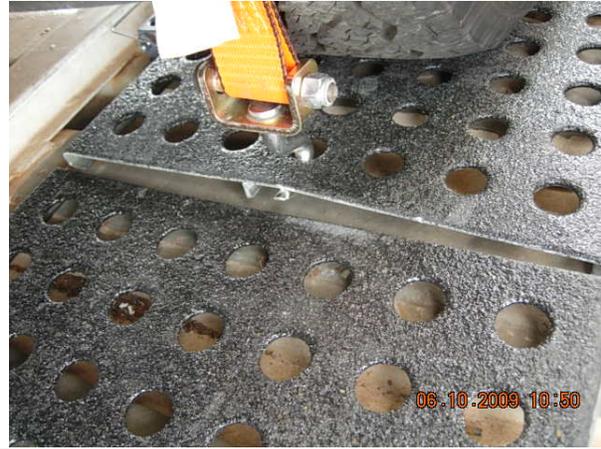
View of decking lifted by TrinityRail system.

IMPACT NO. 3 – TARGET SPEED 8.0 MPH FORWARD DIRECTION – Actual speed was 8.0 MPH; Anvil string wheel slide was 18 inches. There was visible movement of all vehicles but all were contained by the securement systems. The end panel of the TrinityRail decking system under the B-1 vehicle was pulled upward ½ inch. The panel appeared to only be under tension and not permanently deformed. (Note – This was observed later during the test after the tension was released and the panel returned to its original shape with no visible permanent deformation).

TRINITYRAIL - There was no problems with clearance issues with the vehicles (Toyota Yaris and Toyota Tundra) secured by this system. The TrinityRail securement track exhibited some slight distortion through a lifting action during the high speed impacts. Upon release of the applied pressure, the tracks returned to normal shape and did not show any signs of permanent deformation. Two systems for installation of the special tracks were used. The system permanently affixed to the deck will make it very difficult to remove and clean debris, snow, ice, etc. from under the track. There is concern with the use of the Shaft Locking pins on the deck that can be lifted to allow cleaning. The locking mechanism of the Shaft Pin is a wire fastener that can potentially be a hazard to snag clothing or footwear or can be easily be disengaged if stepped on. The ability to clean under the decking is desirable but a different locking feature is recommended.

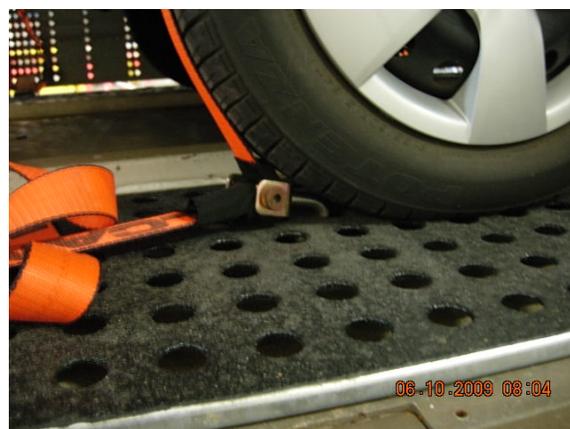
Example the idler hook blocked.

Upon completion of the test, the securement system could not be removed until the vehicle was moved due to the curvature of the tire being over the securement hook which prevented the hook from being released from the track. There was only slight movement of the vehicle during the test but it was sufficient to prevent hook release. This is a major concern that would affect unloading personnel due to the extra handling and potential exposure to damage to the vehicle and it would also require additional unloading time. The length of the straps may potentially be an issue as the straps from one vehicle and those from another may overlap. The strap system is somewhat difficult to handle because of the winch at the end of the strap and the various hooks used to secured the strap to the deck. Application is more time consuming the other systems.

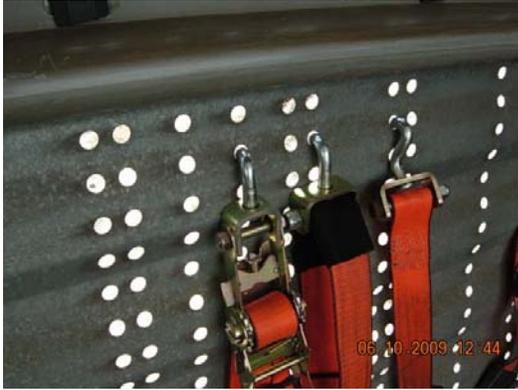
TrinityRail Storage system.

Two storage methods for the TrinityRail device were also used. One method was simply to hang the hook end of the strap over the edge of a side screen and a second method was to place the hook through one hole in the side panel.

The TrinityRail strap storage system with the hook hanging on the lip of the side screen disengaged and was lying on the autorack deck. The storage system with the hook inserted through a hole in the side panel remained secured. There were no other defects noted, no visible damage to test components, vehicles or railcar.

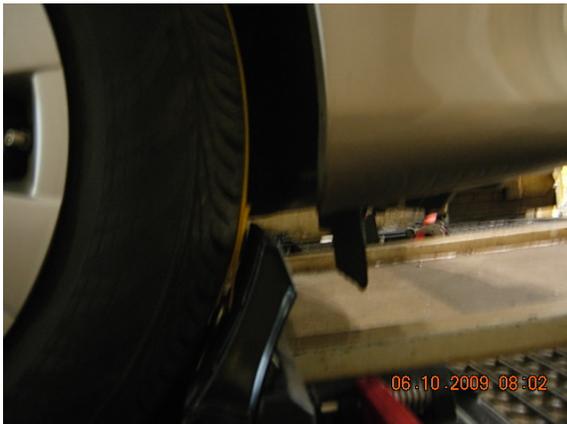
View showing close clearance between chock and vehicle.

ZEFTEK – After installation of the securement system, there was only 1 inch clearance between the chocks and the ground effects at the front of the A-1 vehicle (Toyota Corolla), a tri-level product. This was observed and monitored throughout the test and at the conclusion it did not appear that there had been any contact. There was adequate clearance between chock and body components of the other vehicle (Toyota RAV) secured with the ZefTek system.
