**Subject; Holden Gravity Outlet Gates # CC-264-17-16**

**AAR S-233-92 TESTING OF THE HOLDEN INTERNATIONAL INC.**  
**42 x 42 GRAVITY DISCHARGE OUTLET GATE**  
**(MODEL FDU4242FB1NV)**

In accordance with the Holden International application submitted in August 2008, for approval of the 42 x 42 Gravity Discharge Outlet Gate, we are hereby documenting the test results as required by AAR S-233-92 specification.

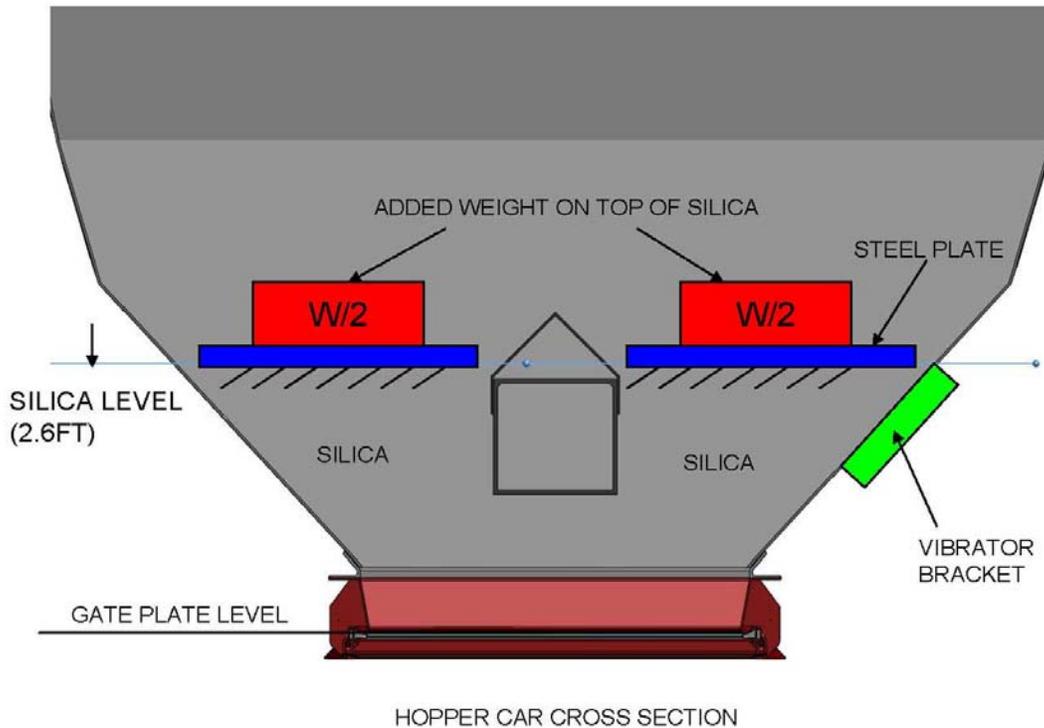
## 42x42 Gate Vibration Test Setup

The test hopper was filled with 90 cubic feet of fine, dry silica sand with a depth of 30 inches from the gate plate. Then, 20,160 lbs of additional dead weight (concrete blocks over steel footings) were added to achieve the required 6 psi loading on the gate plate surface. Please refer to Appendix C for calculation details of additional dead weight required to achieve 6 psi loading on the gate plate surface, and see Pictures 3 and 4 in Appendix D for photos of the test setup.

$h_{\text{silica.total}} = 2.6 \text{ ft}$  Total height of silica above gate plate. This corresponds to a volume of 90 cu-ft.

$$W_{\text{extra}} := (P_{\text{req}} - P_{\text{silica}}) \cdot 2 \cdot A_{\text{steel.plate}} = 19434\text{lb}$$

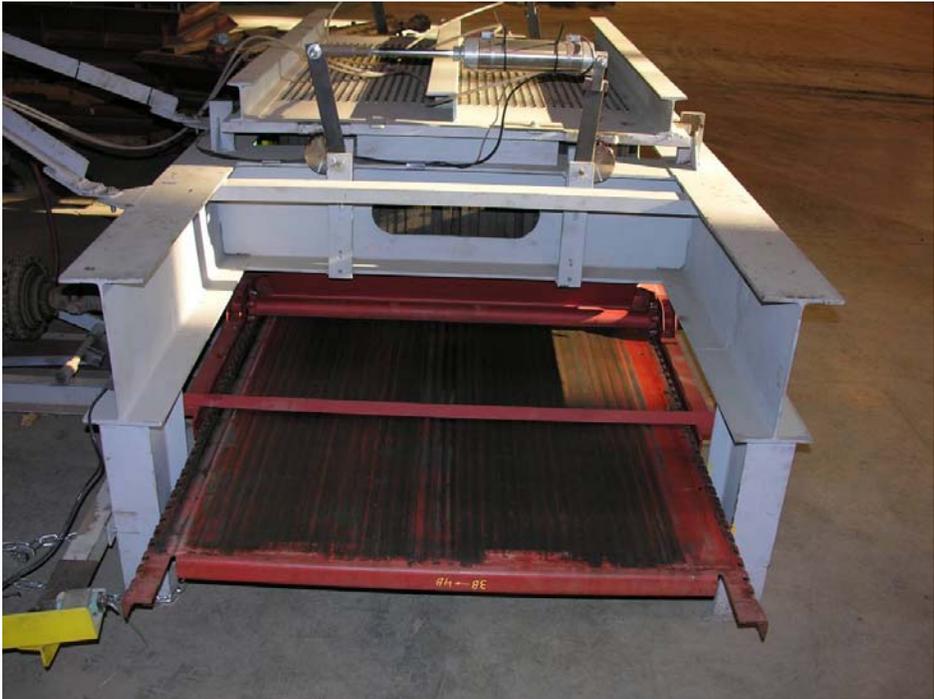
The automated cycle test rig houses 6 lb vertical bars each having a cross-sectional area of 1 square inch which apply 6 psi pressure on the gate plate surface. (See Picture 1 in Appendix D). When the gate plate was closed the bars were lowered automatically to apply the required 6 psi load on the gate plate. As the gate plate was driven open, rows of bars dropped past the edge of the gate plate in successive rows until the gate plate was completely opened and unloaded. The bars were then raised automatically so the gate plate could be driven automatically back to a closed position and the cycle could repeat itself. On Tuesday November 3, 2009, 500 cycles were completed and on Wednesday November 4, 2009, another 500 cycles were completed for a total of 1000 cycles.

**PICTURE 1: CYCLE TEST RIG AND TEST GATE**

After 1000 cycles, the test gate was operated without becoming loose or binding. The breakaway torque was measured with a calibrated torque measuring device and the recorded value of the torque was 550 ft lbs. Consequently, the outlet gate met the AAR Cycle Test requirement, as per S-233-92, Sec 3.1.

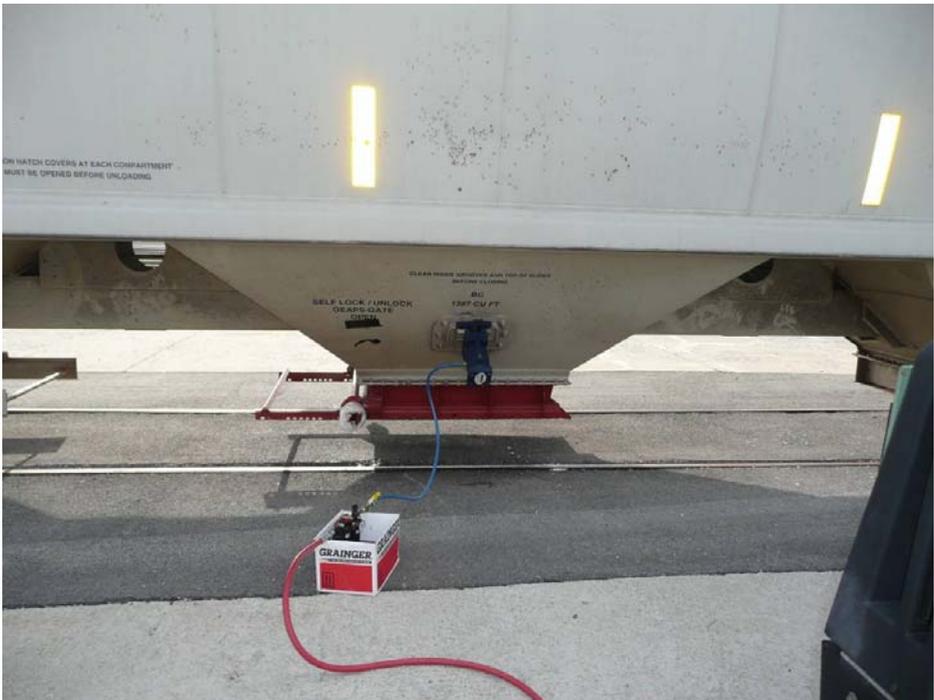
The test gate was applied on test hopper car FURX 863424. Empty Car Vibration Test was conducted on December 2, 2009 at the Belt Railway of Chicago (BRC) yard in Bedford Park, Illinois. Present were Varouj Khatchadourian from Holden and Mr. Steve Berkshire on behalf of the AAR. Please see setup in Picture 2 in Appendix D

The portable vibrator selected had a 3 inch diameter cylinder, 80 psi operating pressure and it imparted over 15,000,000 ft-lb of energy during the 222 minutes (3 hours and 42 minutes) that it operated per the calculation in Appendix B.

**PICTURE 2: EMPTY CAR VIBRATION TEST**

As the test ran continuously for 222 minutes (3 hours and 42 minutes), the vibrator energy output was 15,549,122 ft-lb which is well over the 15,000,000 ft-lb minimum AAR requirement. Consequently and since no damage on the gate or hopper structure was observed, the outlet gate met the AAR Empty Hopper Vibration Test requirement of S-233-92, Sec 3.2.

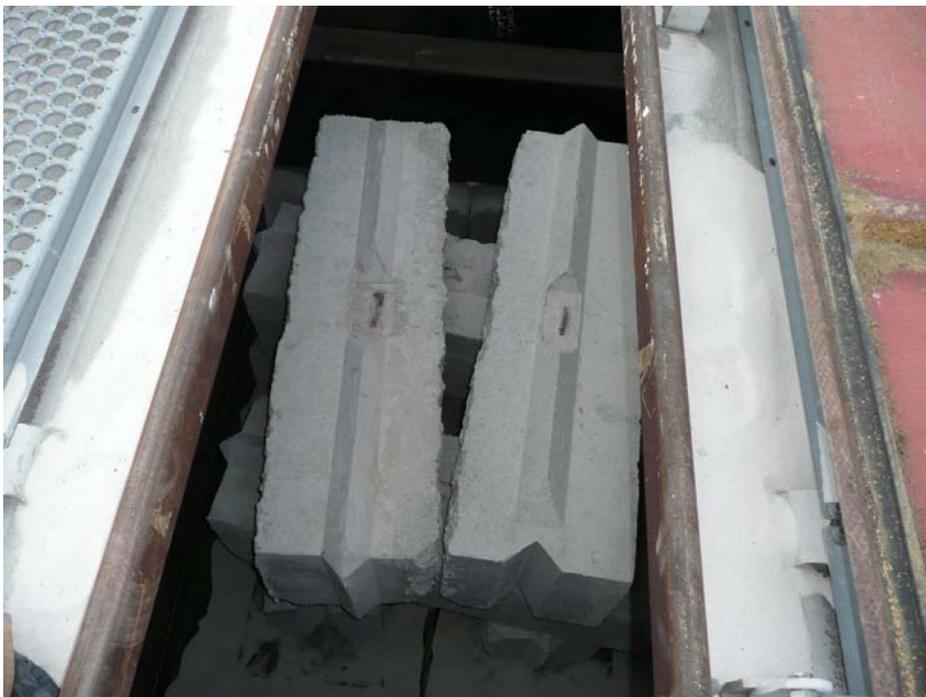
**PICTURE 4: HOPPER LOADED WITH CONCRETE BLOCKS FOR TIGHTNESS TEST**

A receptacle which was applied on the test gate prior to commencement of the Tightness Test was removed after the test was completed and it showed that no silica sand leakage (0 ounces after 1 hour of testing) occurred during the test versus 8 oz. allowable by the specification. Consequently, the outlet gate met the AAR Tightness Test requirement of S-233-92, Sec 3.3.

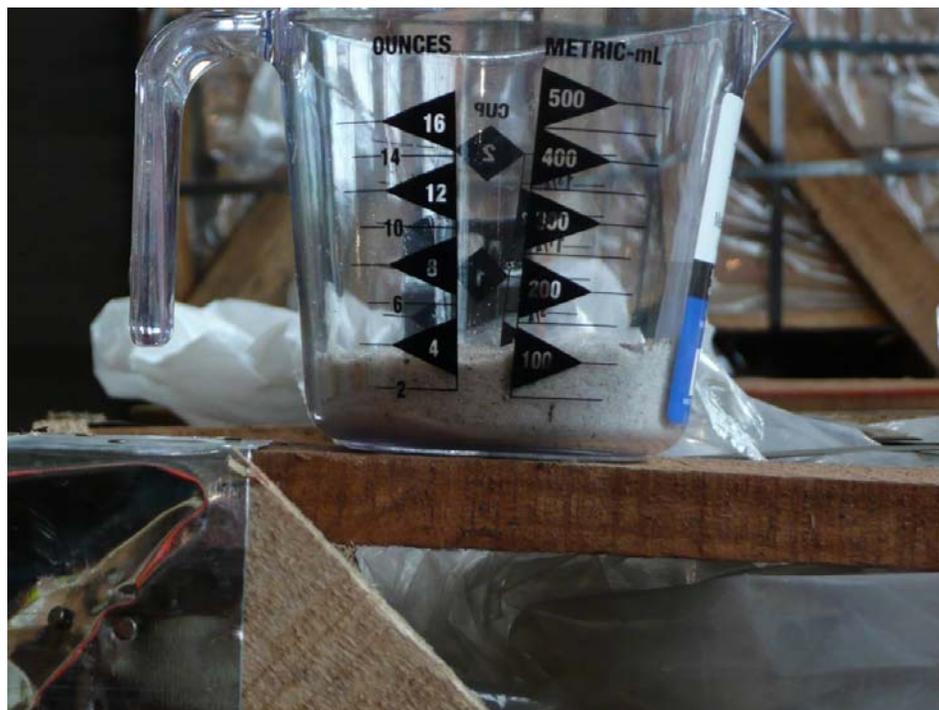
Loaded Car Impact Tests were conducted at speeds in 2 mph increments starting at 2 mph and up to 10 mph, in accordance with S-233-92, Sec 3.4. A radar gun was used to record the impact speed of the test hopper car as it impacted the anvil cars. The actual speeds recorded were 1 mph, 2.9 mph, 4.5 mph, 7 mph, 8 mph and 11.3 mph. The test car was then reversed and a reverse impact test was conducted at exactly 10 mph. The blue plastic canvas collector that was tightly applied around the test gate to collect any leaked sand was very carefully removed and taken to the shop for measurement of the amount of sand that leaked. The measured amount of lading loss was 4 ounces after 10 minutes, which is half of the amount allowable by S-233-92, Sec 3.4.4.1. (Please see Picture 5 in Appendix D). The test gate was then inspected and the gate plate was found to be fully closed with the locking mechanism properly engaged. The test hopper was then emptied and the test gate was operated through a complete cycle (opened and closed) and the operating mechanism was shown to function properly. Consequently, the outlet gate met the AAR Loaded Car Impact Test requirement of S-233-92, Sec 3.4.4.

**PICTURE 5: LOADED CAR IMPACT TEST RESULT SHOWING 4 OZ. LEAKAGE AFTER 10 MINUTES**

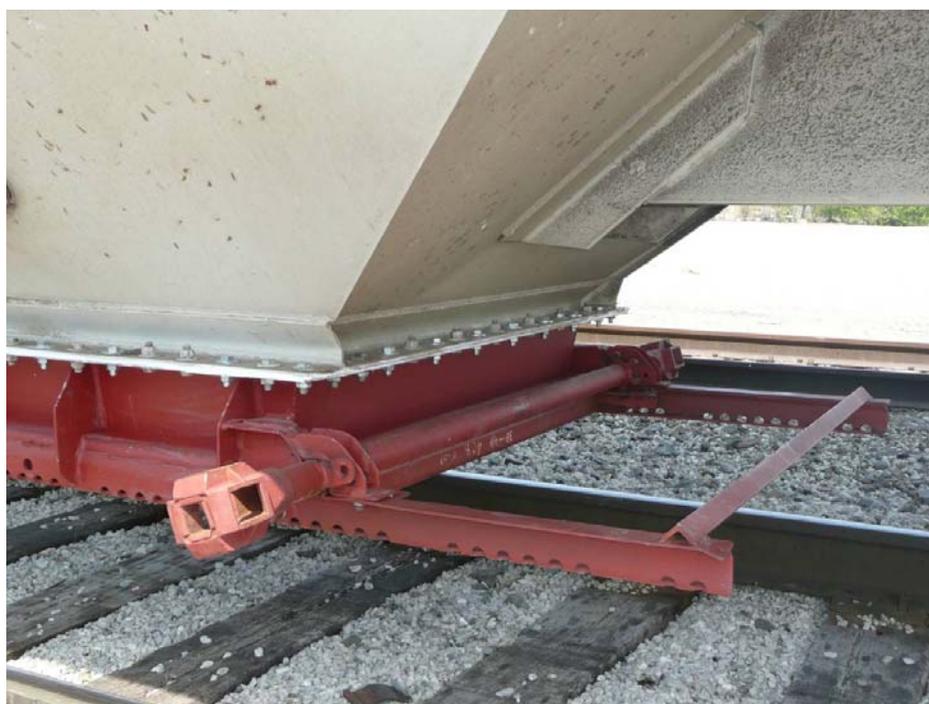
The Empty Car Impact Test was therefore repeated on April 14, 2010 when warmer weather permitted conducting the Water Spray Test. Present at this test were Varouj Khatchadourian and Diego Pino from Holden and Mr. Dan Healy from the AAR. The impact speed recorded for the 10 mph reverse impact test was 10.4 mph. After the reverse impact test, the test gate was

inspected and the gate plate was found to be fully closed with the locking mechanism properly engaged. The test gate was then operated through a complete cycle (opened and closed) and the operating mechanism was shown to function properly. Please see Picture 6 in Appendix D. Consequently, the outlet gate met the AAR Empty Car Impact Test requirement of S-233-92, Sec 3.4.4.

**PICTURE 6: TEST GATE FULLY CLOSED AFTER 10.4 MPH EMPTY CAR IMPACT TEST**

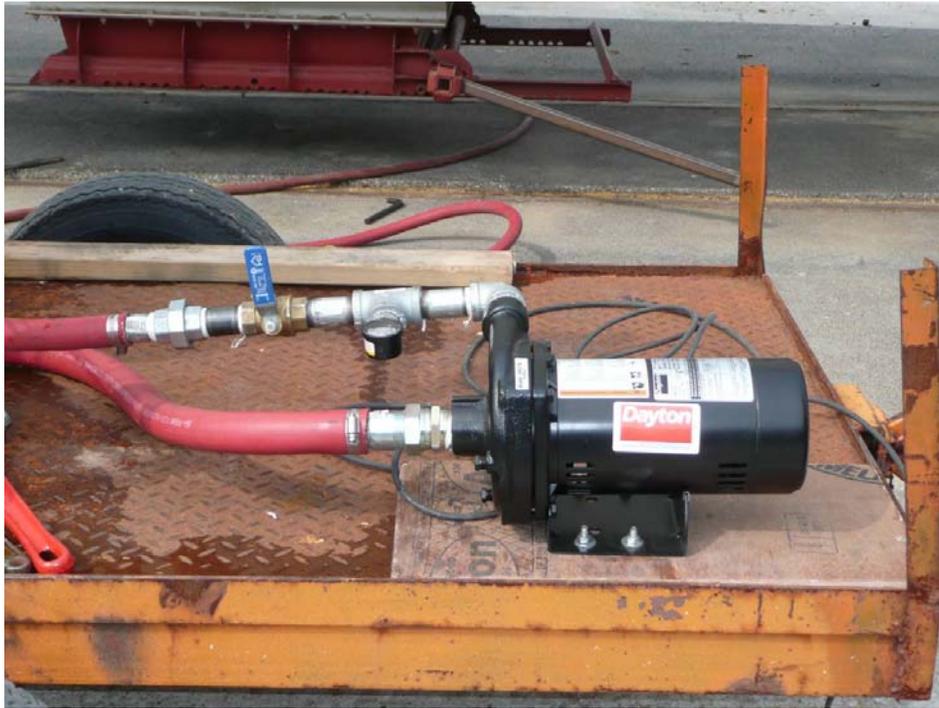
The Water Spray Test was therefore performed on April 13, 2010 at the BRC yard in the presence of Mr. Dan Healy of the AAR. Present from Holden were Varouj Khatchadourian and Diego Pino. Please see Picture 7 in Appendix D for test setup.

The stream of water from a nozzle verified to comply with the requirements of Sec 3.5 was applied to the seals and the joints of the test gate in accordance with the requirements. Upon completion of this test, the interior of the test gate was checked and found to be completely free from water penetration. Consequently, the gate outlet met the AAR Water Spray Test requirement.

**PICTURE 7: WATER SPRAY TEST RIG**
