# Holden Grate-Lock™ Chock Inspection and Repair Standards: Procedure and Examples (April 2016)

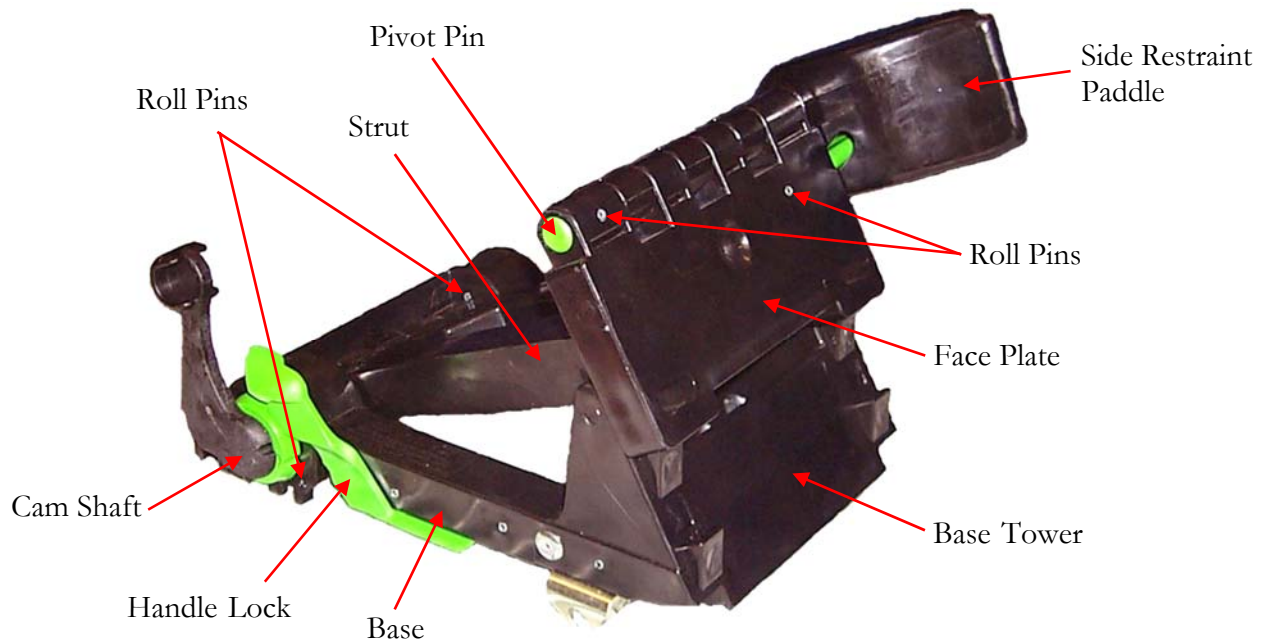
**Figure 1: Upperside Component Nomenclature**

All major plastic chock components, namely the Base, Strut, and Face Plate should be examined for cracks, fractures, and visible deformations like strain whitening marks. (See Figure 1 for component nomenclature). If defects are found, then the chock is considered to be non-functional and must be repaired or replaced as outlined in the following sections.

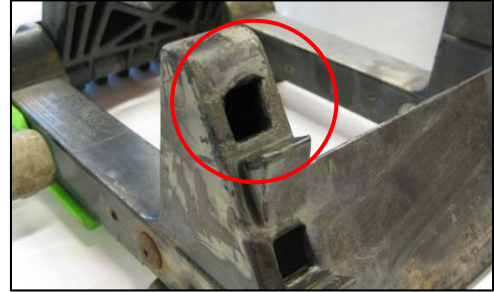
**Figure 2: Elongated Tab Engagement Holes**

- a) The tab engagement holes, found on the Base tower front faces, should be checked for elongation. If the holes are elongated (see Figure 2), the chock is considered to be non-functional and must be replaced.

a)	Base Tower Tab Engagement Holes	Elongated	No	Send for Reconditioning	
	b)	Base Tower	Face Plate does not sit properly	No	Send for Reconditioning	
	c)	Base Cross Web	Strain whitening marks in corners or visible deformation	No	Send for Reconditioning

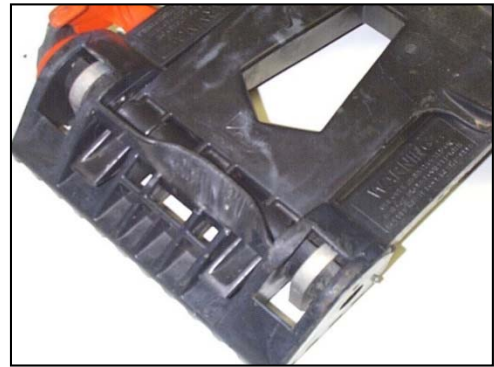
**Figure 3: Deformed Cross Web on Base**

- c) Deformation of the cross web on the top side of the chock Base or strain whitening marks found in the corners of the cross web indicate a weakened structural component. (See Figure 3). In both cases, the chock is considered to be non-functional and must be replaced.

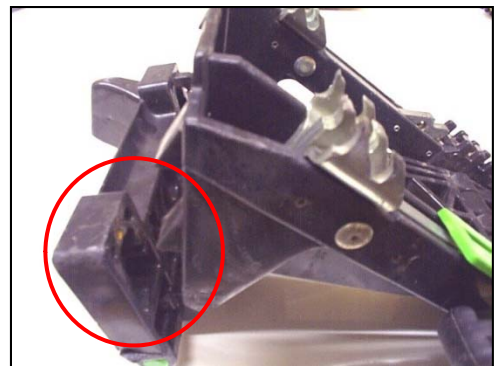
**Figure 4: Missing Face Plate Tabs**

- e) The Face Plate tabs should be checked to ensure that they are neither missing (see Figure 4), nor bent, nor have a hairline crack where they meet the Face Plate. In the latter case, the chock may still appear to be fully functional. However, in all cases the chock is considered to be non-functional and must be replaced.

d)	Strut Side Restraint Paddle	Deformed, bent or cracked near main body	No	Send for Reconditioning	
			Hairline cracks in webbing			
	e)	Face Plate Tabs	Missing, deformed or hairline crack	No	Send for Reconditioning

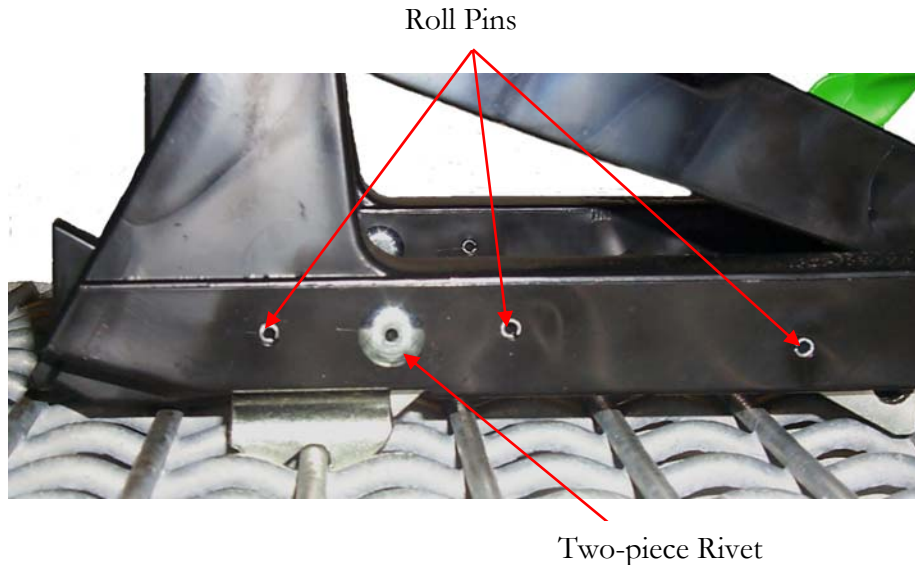
**Figure 5: Side View Component Nomenclature**

- a) The Roll Pins in the Chock Base (12) and in the Face Plate (2) should not be missing or protruding. (See Figures 1 and 5). If any pin is missing, the chock is considered to be non-functional and a new Roll Pin must be replaced in kind. If any pin is protruding by 1/8" or more, it must be **lightly** hammered in until flush with Base surface. These repairs can be performed in the field.
- b) Both Two-piece Rivets should be present and tight up to the Chock Base without any play. If any is missing or not tight, the chock is considered to be non-functional and a new Two-piece Rivet must be replaced in kind. This repair can be performed in the field.

Chock Side	Article	Component	Defect Found	Is Chock Functional?	Recommended Repair Decision	Comments
B. Side View Components	a)	Roll Pins	Protruding by more than 1/8" or missing	No	Repair in the Field	Lightly hammer Roll Pin until it is flush with Base. Order OEM Parts.
	b)	Two-piece Rivets	Not tight or missing	No	Repair in the Field	Remove by drilling through rivet. Order OEM Parts.

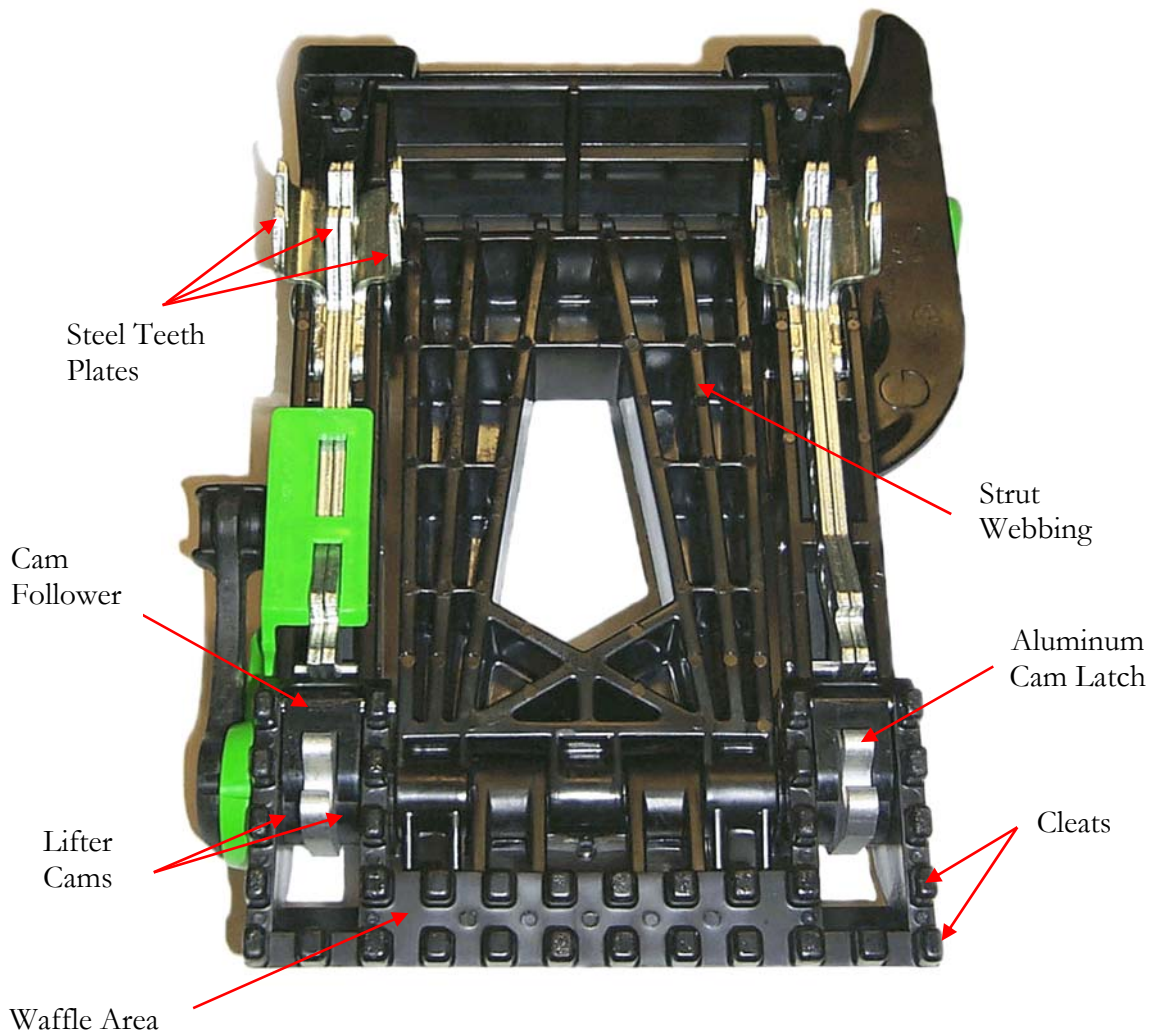
**Figure 6: Underside Component Nomenclature**

All components of the chock should be checked to ensure they are not missing, and have not been deformed or otherwise damaged. (See Figure 6).

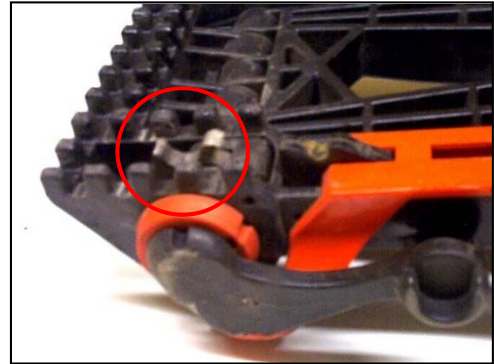
**Figure 8: Broken Cam Latch**

- b) The Aluminum Cam Latches must be checked for distortion or elongation. If any latch tooth is deformed or broken off (see Figure 8), the chock is considered to be non-functional and must be replaced.

C. Underside Components	a)	Steel Teeth Plates	Missing Plates or Adjacent Tooth tips bent	No	Send for Reconditioning	
	b)	Grating Latch Teeth	Deformed or broken	No	Send for Reconditioning	
	c)	Base Cleats	Two adjacent or three cleats over entire waffle area broken or missing	No	Send for Reconditioning	
			Any two non-adjacent cleats over entire waffle area broken	Yes	Repair in the Field	Grip the cleat firmly with pliers and bend away from the Base until it breaks off. Use a file to remove any residual shards.
