Holden Grip-Lock™ Chock Inspection and Repair Standards: Procedure and Examples (April 2016)

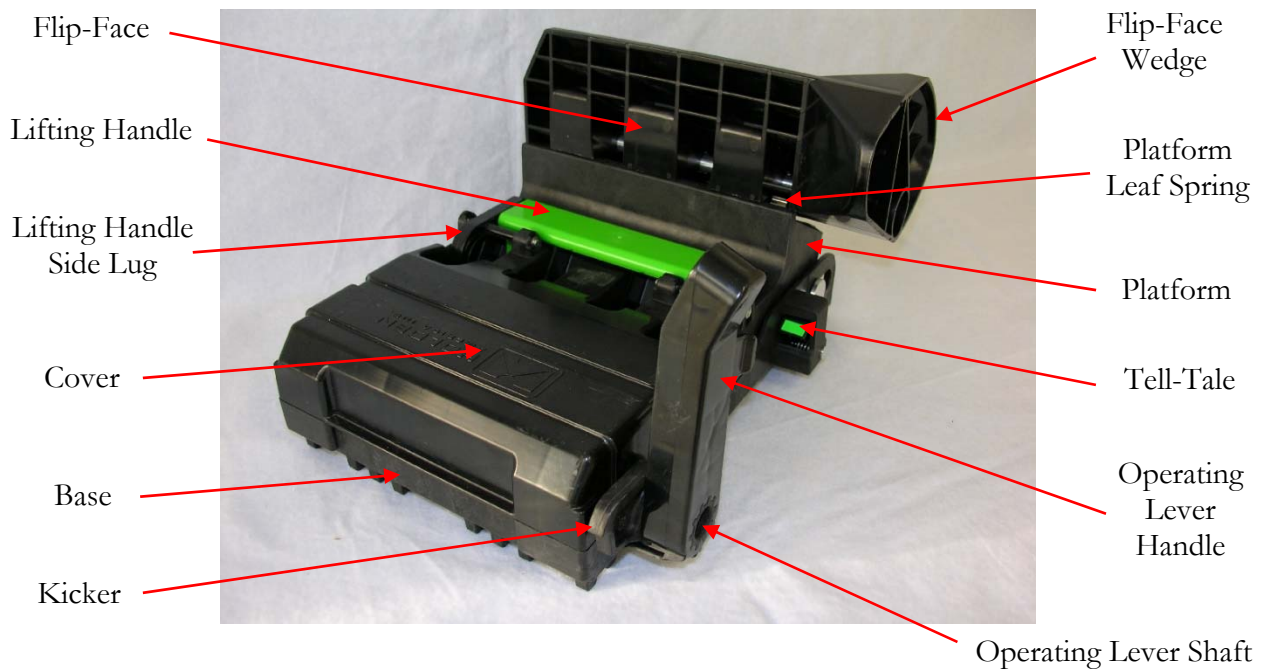
Figure 1: Upperside Component Nomenclature

All major plastic chock components, namely the Base, Platform, Flip-Face, Cover, Operating Lever Shaft and Handle and Lifting Handle and Side Lugs, should be examined for cracks, fractures and visible deformations. (See Figure 1 for component nomenclature). If defects are found, then the chock is considered to be non-functional and must be repaired or replaced as outlined in the following sections.

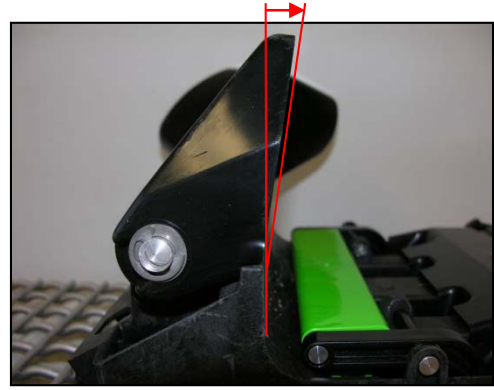
Figure 2a: Flip-Face Rear Side Not Vertical

- a) When flipped in high position, the Flip-Face rear side should be approximately vertical. (See Figure 2a). If not and/or the Flip-Face does not rotate freely, the chock is considered to be non-functional. It must be replaced and sent for reconditioning.

a)	Flip-Face	Not vertical and does not rotate freely	No	Send for Reconditioning	
			Deformed ribs	No	Send for Reconditioning	
	b)	Flip-Face Wedge	Deformed	No	Repair in the Field	Order OEM Part.

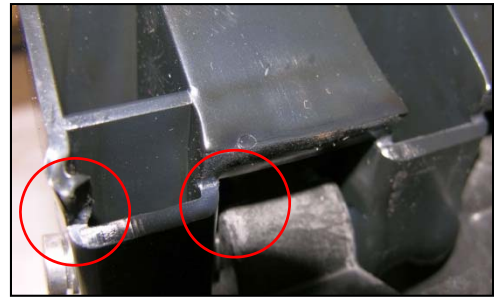
Figure 2b: Flip-Face Ribs Deformed

Additional evidence of this problem would be deformed Flip-Face ribs on the lower portion of Flip-Face rear side. (See Figure 2b).

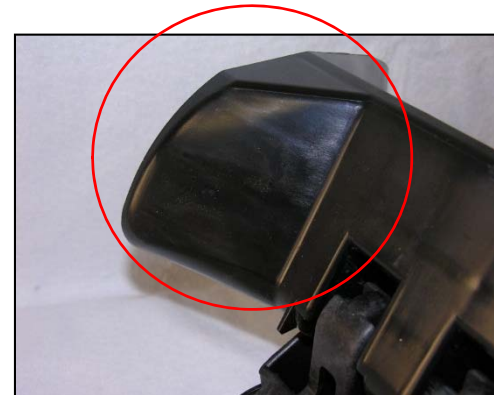
Figure 3: Flip-Face Wedge

- b) The Flip-Face Wedge (see Figure 3) should not be deformed. If it is, the chock is considered to be non-functional and the Flip-Face must be replaced. This repair can be performed in the field.

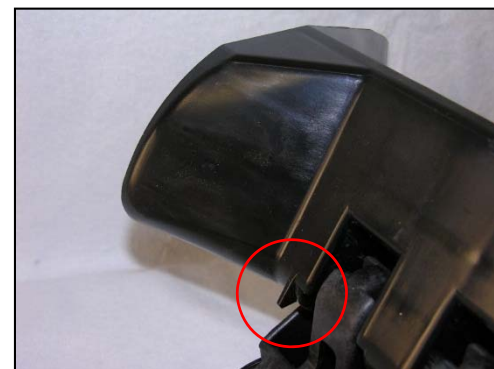
Figure 4: Flip-Face Lug

- c) The Flip-Face high/low position locating lug (see Figure 4) should not be deformed or broken off. If it is, the chock is still considered to be functional. However, the Flip-Face should be replaced at first opportunity. This repair can be performed in the field.

c)	Flip-Face high/low Lug	Deformed or broken off	Yes	Repair in the Field	Can be used as is but should be repaired at first opportunity. Order OEM Part.

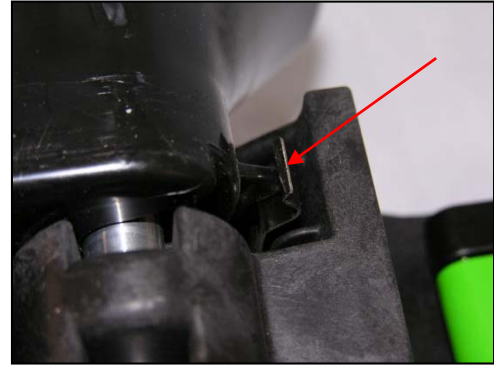
Figure 5: Platform Leaf Spring

- d) The Platform Leaf Spring (see Figure 5) should not be broken or missing. If it is, the chock is still considered to be functional. However, the chock should be replaced at first opportunity and sent for reconditioning.

d)	Platform Leaf Spring	Broken or missing	Yes	Send for Reconditioning	Can be used as is but should be replaced at first opportunity.
	e)	Platform Shelf	Broken	Yes	Send for Reconditioning	Can be used as is but should be replaced at first opportunity.

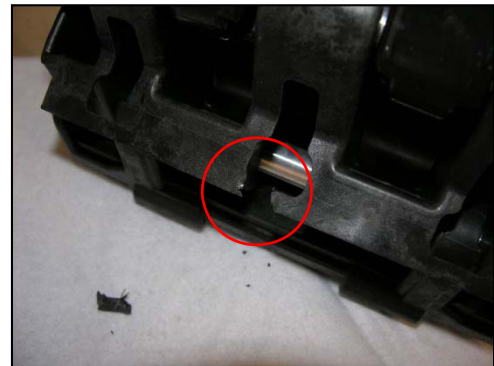
Figure 6: Platform Front Shelf Shown Broken

- e) The Platform front shelf should not be broken. (See Figure 6). If it is, then the chock is still considered to be functional. However, the chock should be replaced at first opportunity and sent for reconditioning.

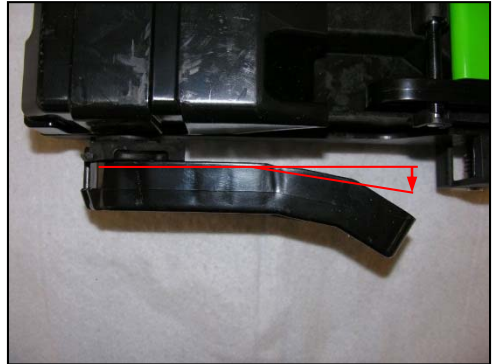
Figure 7: Operating Lever Handle Shown Bent

- f) The Operating Lever Handle should not be deformed. (See Figure 7). If it is, the chock is considered to be non-functional and the Operating Lever Handle must be replaced. This repair can be performed in the field.

f)	Operating Lever Handle	Deformed	No	Repair in the Field	Order OEM Part.
	g)	Operating Lever Handle Clips	One clip bent or broken/missing	Yes	Repair in the Field	Can be used as is but should be repaired at first opportunity.
			Two clips bent or broken/missing	No	Repair in the Field	Order OEM Part.

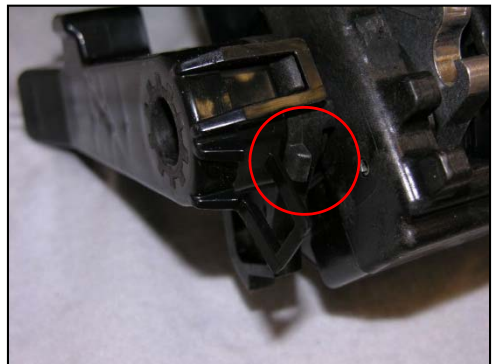
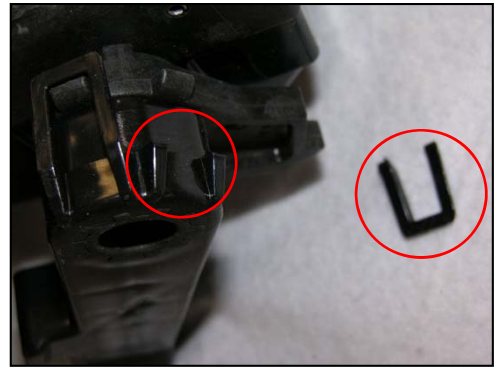
- g) The Operating Lever Handle clips should not be disengaged, bent or broken. (See Figures 8a and 8b). If one clip is damaged, the chock is still considered to be functional. However, the Operating Lever Handle should be replaced at first opportunity. If both clips are damaged, the chock is considered to be non-functional and the Operating Lever Handle must be replaced. This repair can be performed in the field.

Figure 8a: Operating Lever Handle Clip Bent

Figure 8b: Operating Lever Handle Clip Broken

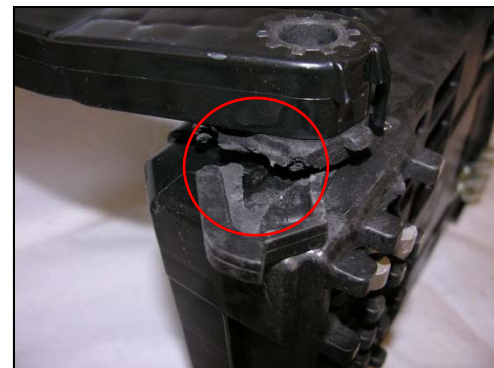
Figure 9: Operating Lever Shaft Kicker Broken

- h) The Operating Lever Shaft kicker should not be broken. (See Figure 9). If it is, the chock is considered to be non-functional. It must be replaced and sent for reconditioning.

h)	Operating Lever Shaft Kicker	Broken	No	Send for Reconditioning	
	i)	Lifting Handle or Side Lugs	Broken, disengaged or missing	Yes	Repair in the Field	Can be used as is but should be repaired at first opportunity. Order OEM Part.

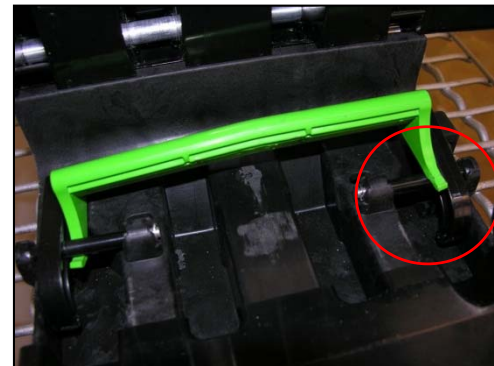
Figure 10: Lifting Handle Shown Disengaged

- i) The Lifting Handle and/or Side Lugs should not be broken, disengaged or missing. (See Figure 10). If any is, the chock is still considered to be functional but the Lifting Handle and/or Side Lugs should be replaced at first opportunity. This repair can be performed in the field.

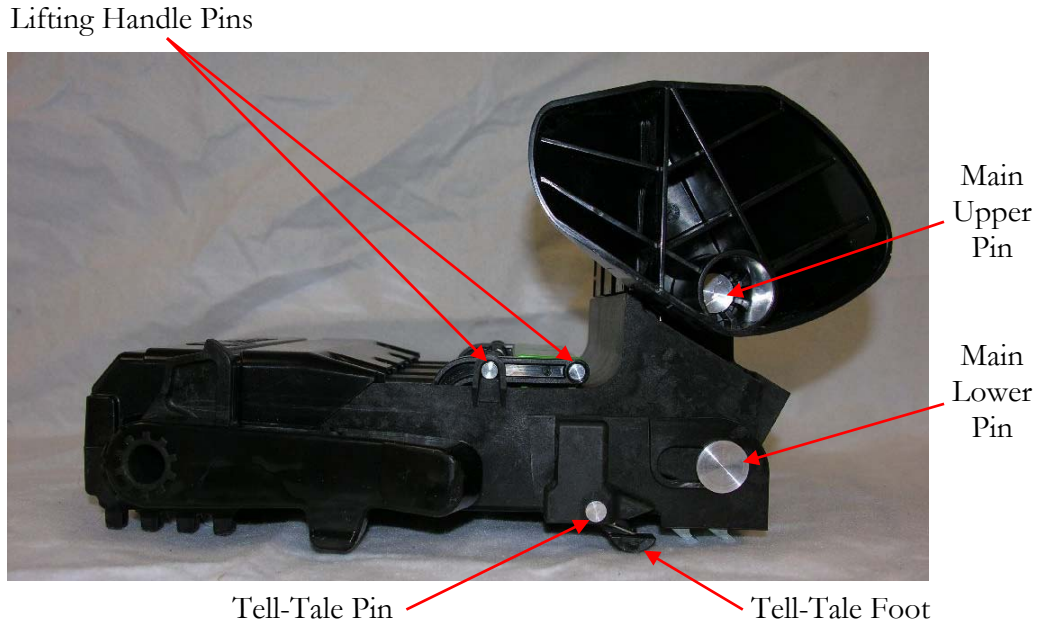
Figure 11a: Field Side Component Nomenclature

All components of the chock should be checked to ensure they are not missing, and have not been deformed or otherwise damaged. (See Figures 11a and 11b).

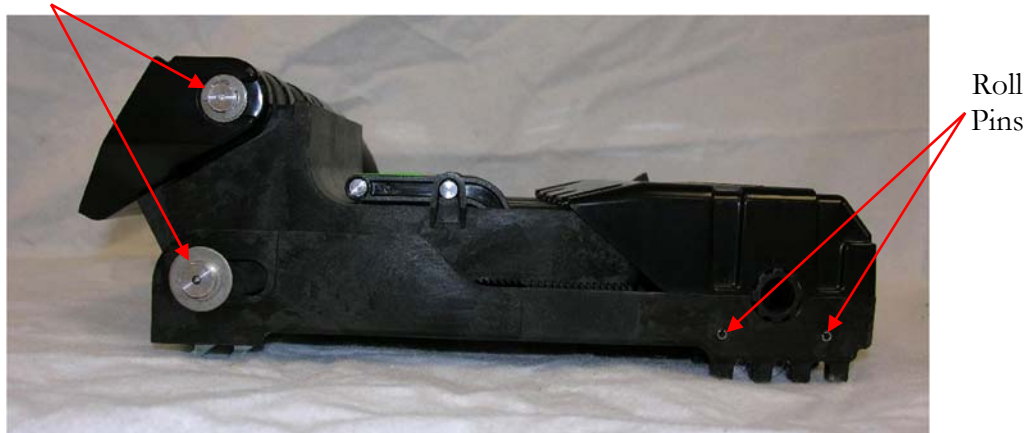
Figure 11b: Inboard Side Component Nomenclature

Main Pin Retaining Rings & Washers

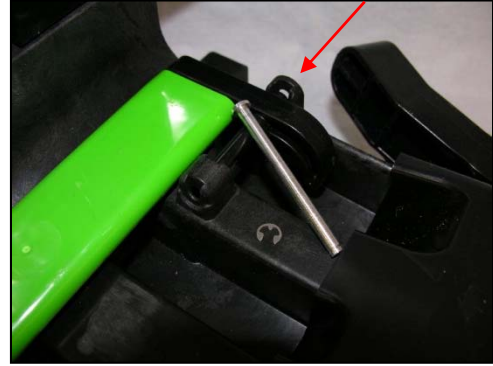
Figure 12: Lifting Handle Hardware Missing

- a) The Lifting Handle Pins and Retaining Rings should not be missing. (See Figure 12). If any of the hardware is missing, the chock is still considered to be functional but the missing hardware should be replaced in kind at first opportunity. This repair can be performed in the field.

a)	Lifting Handle Pins & Rings	Missing	Yes	Repair in the Field	Can be used as is but should be repaired at first opportunity. Order OEM Part.
	b)	Main Pin Washers & Rings	Missing	No	Repair in the Field	Order OEM Parts

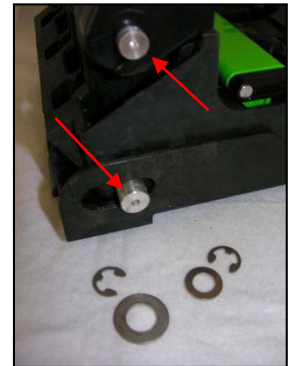
Figure 13: Main Pin Hardware Missing

- b) The Main Pin Washers and Retaining Rings should not be missing. (See Figure 13). If any of the hardware is missing, the chock is considered to be non-functional and the missing hardware must be replaced in kind. This repair can be performed in the field.

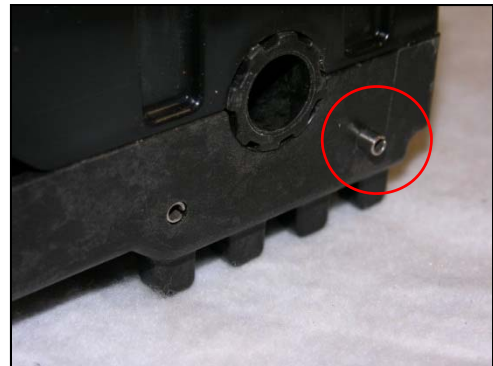
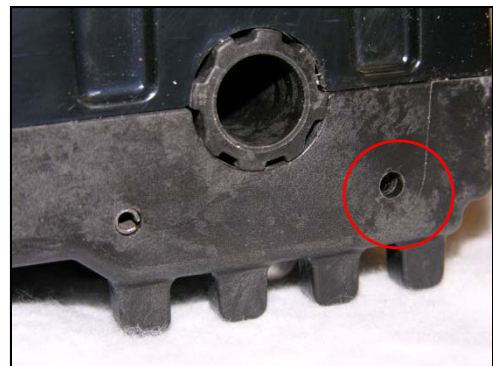
- c) The Roll Pins should not be missing, protruding or recessed. (See Figures 14a and 14b). If any pin is missing or protruding by more than 1/8" or is recessed by more than 1/16", the chock is considered to be non-functional. It must be replaced and sent for reconditioning. If any pin is protruding by 1/8" or less, it must be **lightly** hammered in until flush with Base surface. This repair can be performed in the field.

Figure 14a: Roll Pin Protruding

Figure 14b: Roll Pin Recessed

c)	Roll Pins	Protruding by more than 1/8", recessed by more than 1/16" or missing	No	Send for Reconditioning	
			Protruding by 1/8" or less	Yes	Repair in the Field	Lightly hammer Roll Pin until it is flush with Base

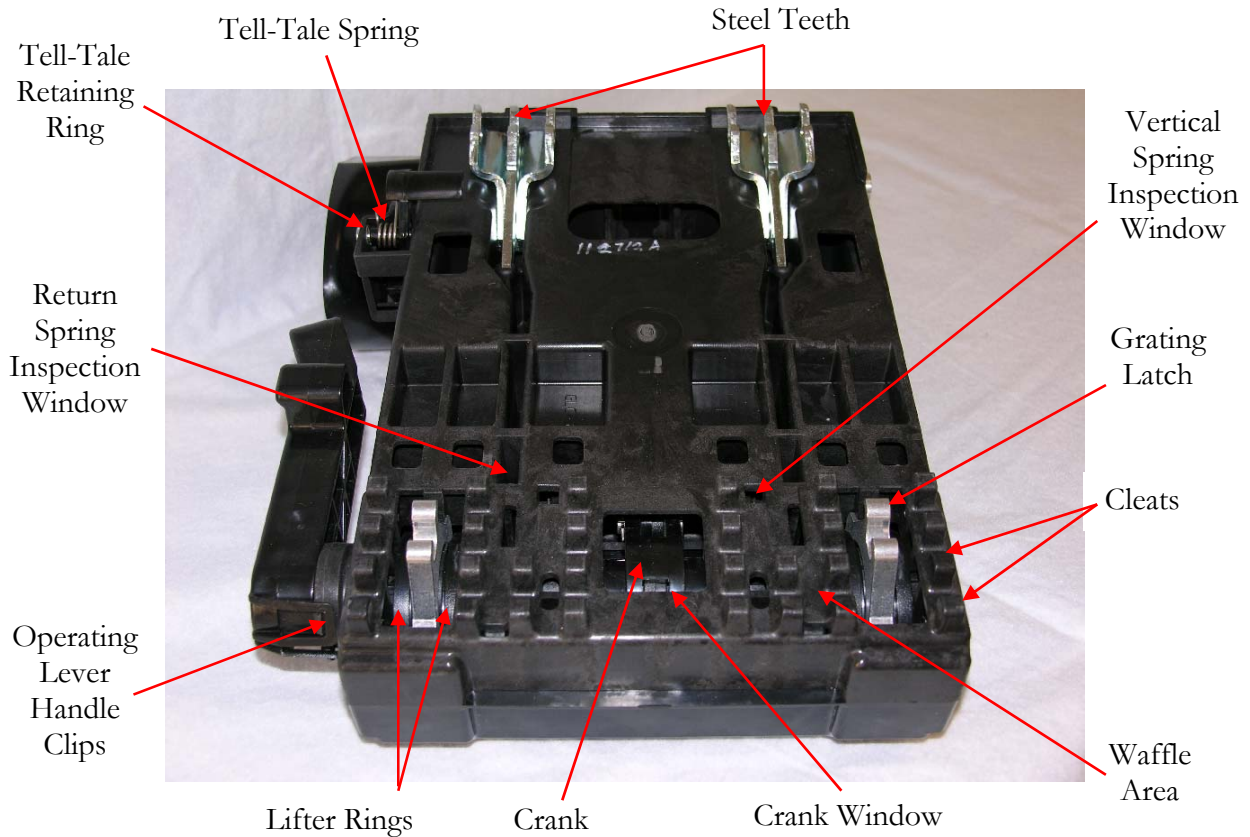
Figure 15: Underside Component Nomenclature

All components of the chock should be checked to ensure they are not missing, and have not been deformed or otherwise damaged. (See Figure 15).

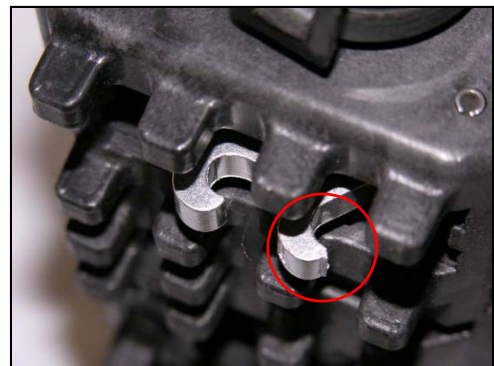
Figure 16: Elongated Grating Latch Teeth

- a) The Grating Latch teeth should be checked for distortion or elongation. If either tooth is deformed or broken off (see Figure 16), the chock is considered to be non-functional. It must be replaced and sent for reconditioning.

C. Underside Components	a)	Grating Latch Teeth	Deformed or broken	No	Send for Reconditioning	
	b)	Base Cleats	Two adjacent or three cleats over entire waffle area broken or missing	No	Send for Reconditioning	
			Any two non-adjacent cleats	Yes	Repair in the Field	Grip the cleat firmly with pliers and bend away from the Base

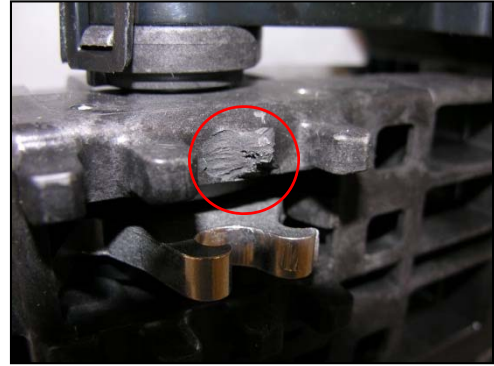
Figure 17: Missing Cleats on Waffle Area

- b) All the cleats in the “waffle area” found on the chock underside should be straight. If two adjacent cleats or more than three cleats over the entire waffle area are missing (see Figure 17), the chock is considered to be non-functional. It must be replaced and sent for reconditioning.

Chock Side	Article	Component	Defect Found	Is Chock Functional?	Recommended Repair Decision	Comments
C. Underside Components (con't)			over entire waffle area broken			until it breaks off. Use a file to remove any residual shards.

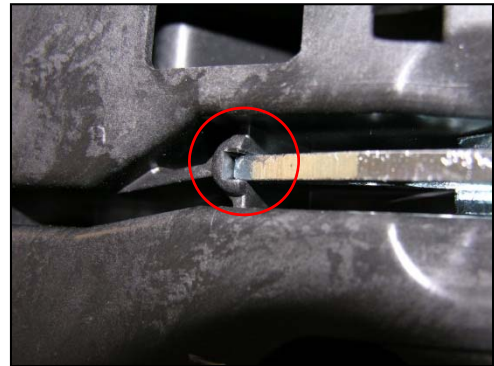
Figure 18a: Steel Teeth Tail in Pocket

- c) The Steel Teeth Insert Assembly tail should be seated deep in the Base rear stop pocket. (See Figure 18a).

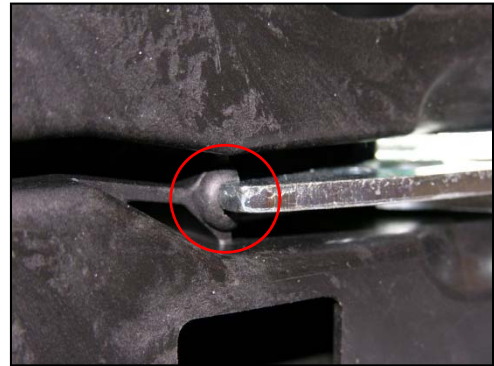
Figure 18b: Steel Teeth Tail not in Pocket

If the tail sits on top of the rear stop (see Figure 18b), the chock is considered to be non-functional. It must be replaced and sent for reconditioning.

c)	Steel Teeth Tail	Tail not seated properly	No	Send for Reconditioning	
	d)	Steel Teeth	Adjacent tooth tips deformed	No	Send for Reconditioning	
	e)	Tell-Tale Foot	Deformed or missing	No	Repair in the Field	Order OEM Part

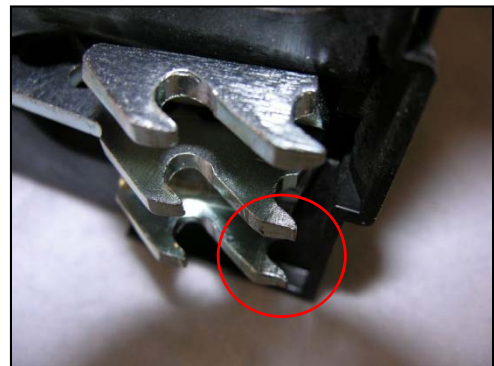
Figure 19: Steel Teeth Shown Deformed

- d) The Steel Teeth tips should be straight. If adjacent tooth tips have been deformed (see Figure 19), the chock is considered to be non-functional. It must be replaced and sent for reconditioning.

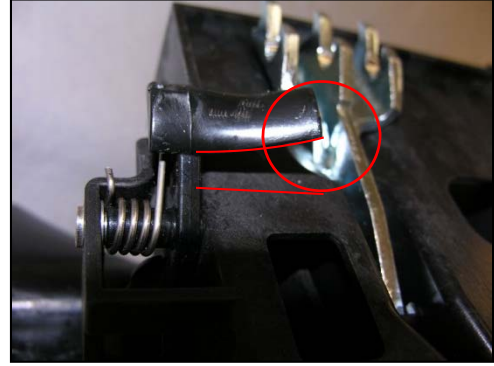
Figure 20: Tell-Tale Foot Shown Deformed

- e) The Tell-Tale foot should not be deformed or broken. (See Figure 20). If it is, the chock is considered to be non-functional and the Tell-Tale must be replaced. This repair can be performed in the field.

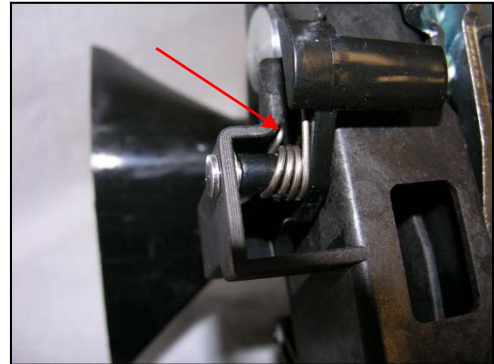
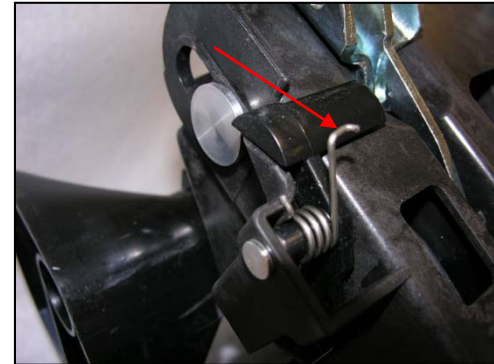
- f) The Tell-Tale spring ends should not be disengaged. (See Figures 21a and 21b). If one or both ends are not seated properly, the chock is considered to be non-functional and the spring ends must be re-engaged in their proper seat. This repair can be performed in the field.

Figure 21a: Tell-Tale Spring End Disengaged

Figure 21b: Tell-Tale Spring End Disengaged

f)	Tell-Tale Spring	Ends not seated properly or disengaged	No	Repair in the Field	Reseat Tell-Tale spring ends using long-nose pliers
	g)	Tell-Tale Ring	Partially seated or missing	No	Repair in the Field	Order OEM Part

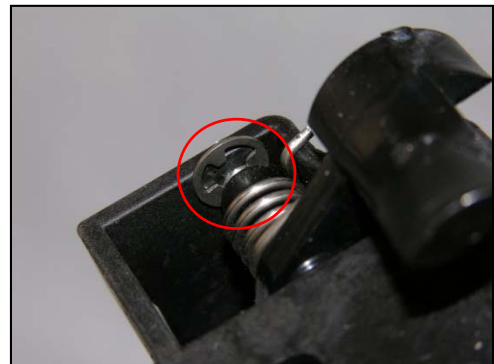
Figure 22: Tell-Tale Retaining Ring Not Seated

- g) The Tell-Tale Retaining Ring should not be partially seated or missing. (See Figure 22). If it is, the chock is considered to be non-functional and the Tell-Tale Retaining Ring must be pushed in until it seats properly or it must be replaced in kind if missing. This repair can be performed in the field.

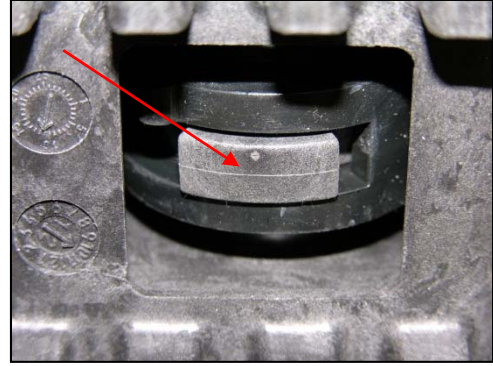
Figure 23: Crank Drive Ring Knob

- h) The Crank Drive Ring knob (see Figure 23) must be visible in the Crank window. If it is missing (broken), the chock is considered to be non-functional. It must be replaced and sent for reconditioning.

h)	Crank Drive Ring Knob	Broken or missing	No	Send for Reconditioning	
	i)	Vertical Springs	Loops not visible in inspection window	No	Send for Reconditioning

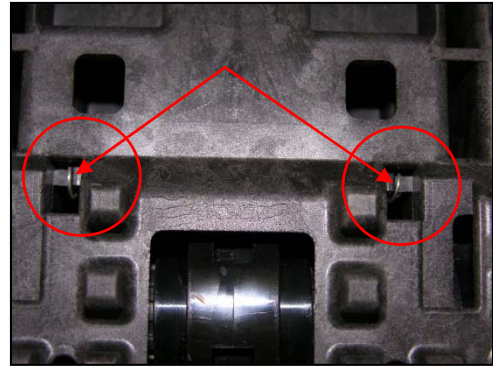
Figure 24: Vertical Spring Loops Shown Engaged

- i) The Vertical Spring loops must be engaged in the Base's internal hooks. (See Figure 24). If either spring loop is not visible in the Base inspection window, the chock is considered to be non-functional. It must be replaced and sent for reconditioning.

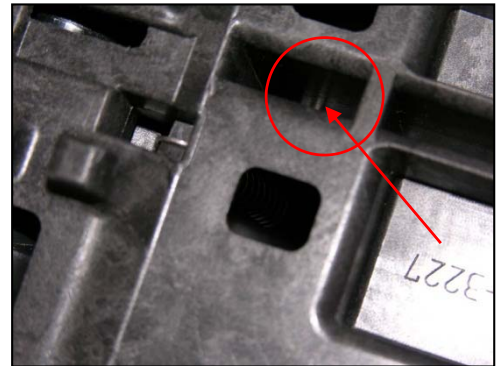
Figure 25: Return Spring Loops Shown Engaged

- j) The Return Spring loops must be engaged in the Base's internal hooks. (See Figure 25). If either spring loop is not visible in the Base inspection window, the chock is considered to be non-functional. It must be replaced and sent for reconditioning.

j)	Return Springs	Loops not visible in inspection window	No	Send for Reconditioning	
	k)	Return Springs	Loops not visible in inspection window	No	Send for Reconditioning

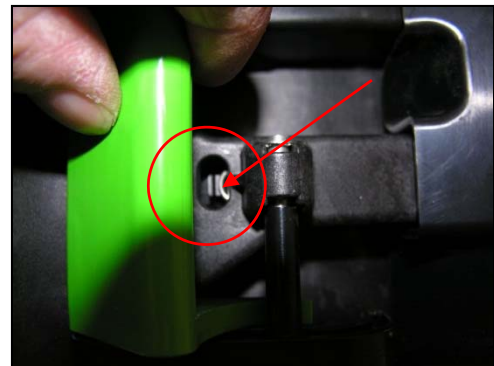
Figure 26: Return Spring Loops Shown Engaged

- k) The Return Spring loops must be engaged in the Platform's internal hooks. (See Figure 26). If either spring loop is not visible in the Platform inspection window under the Lifting Handle, the chock is considered to be non-functional. It must be replaced and sent for reconditioning.
